North Medford High School

Medford SD 549C

FEMA 154 Rapid Visual Screening Score Card

Rapid Visual Screening - Senate Bill #2 - Seismic Needs Assessment
Oregon Department of Geology and Mineral Industries

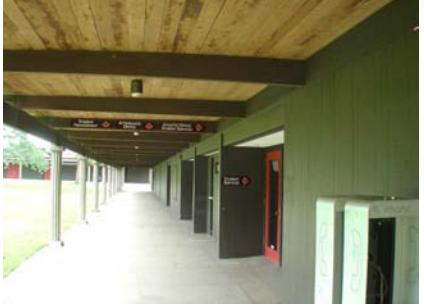
E Primary Structural Type

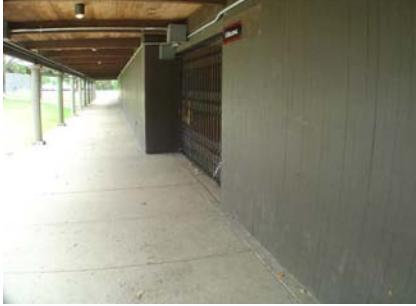
Enrollment 1941	Year Built (Field Verified) 1967	Year Built (Alt. Source) 1967	Est. Decade Built 1960
Total Area (square ft) 192822	Number of Stories 1	Basement	Pounding Potential No
Plan Irregularities Out of Plane Lateral-Force-Resistance Elements None None		Vertical Irregularities None None None	
Falling Hazards None None None		Poor Conditions None None None

E Plan Irregularity Primary

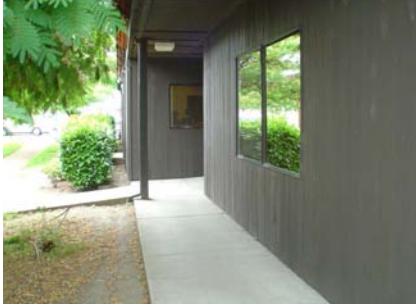
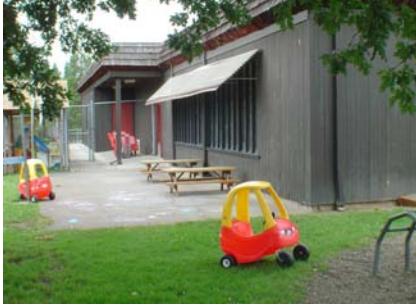
Enrollment 1941	Year Built (Field Verified) 1967	Year Built (Alt. Source) 1967	Est. Decade Built 1960
Total Area (square ft) 192822	Number of Stories 1	Basement	Pounding Potential No
Plan Irregularities Out of Plane Lateral-Force-Resistance Elements None None		Vertical Irregularities None None None	
Falling Hazards None None None		Poor Conditions None None None

N Plan Irregularity Primary		SE Plan Irregularity Primary

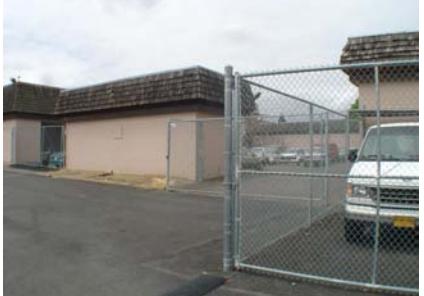
Enrollment 1941	Year Built (Field Verified) 1967	Year Built (Alt. Source) 1967	Est. Decade Built 1960
Total Area (square ft) 192822	Number of Stories 1	Basement	Pounding Potential No
Plan Irregularities Reentrant Corners: U shaped None None		Vertical Irregularities None None None	
Falling Hazards None None None		Poor Conditions None None None

E Plan Irregularity Primary

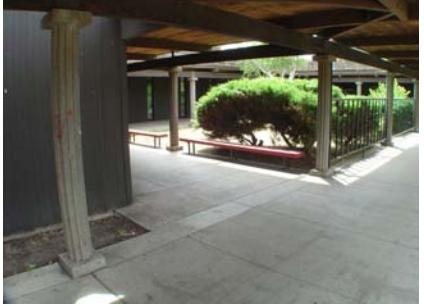
Enrollment 1941	Year Built (Field Verified) 1967	Year Built (Alt. Source) 1967	Est. Decade Built 1960
Total Area (square ft) 192822	Number of Stories 1	Basement	Pounding Potential No
Plan Irregularities Reentrant Corners: U shaped Reentrant Corners: U shaped None		Vertical Irregularities None None None	
Falling Hazards None None None		Poor Conditions None None None

W Plan Irregularity Primary

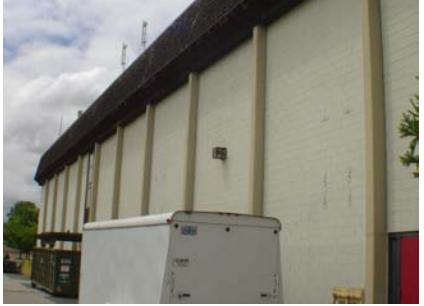
High (>10%)

Enrollment 1941	Year Built (Field Verified) 1967	Year Built (Alt. Source) 1967	Est. Decade Built 1960
Total Area (square ft) 192822	Number of Stories 2	Basement	Pounding Potential No
Plan Irregularities None None None		Vertical Irregularities Internal Discontinuous Diaphram (large internal opening) None None	
Falling Hazards None None None		Poor Conditions None None None

E Secondary Structural Type

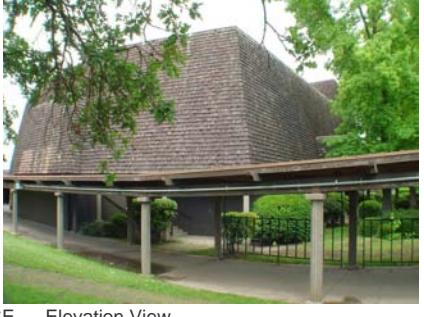
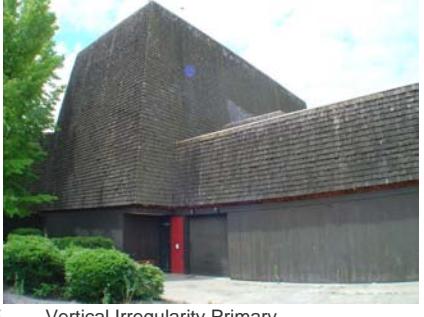
High (>10%)

Enrollment 1941	Year Built (Field Verified) 1967	Year Built (Alt. Source) 1967	Est. Decade Built 1960
Total Area (square ft) 192822	Number of Stories 1	Basement	Pounding Potential No
Plan Irregularities		Vertical Irregularities	
Out of Plane Lateral-Force-Resistance Elements		Steps in Elevation View: Very Irregular Changes	
Non-Parallel System		None	
None		None	
Falling Hazards		Poor Conditions	
None		None	
None		None	
None		None

SE Elevation View		E Vertical Irregularity Primary

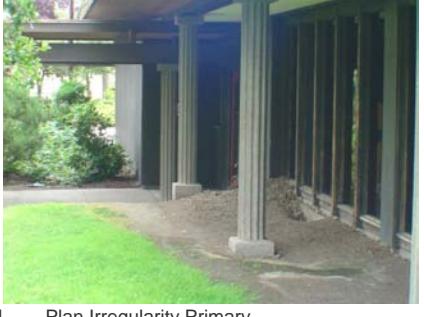
Enrollment 1941	Year Built (Field Verified) 1967	Year Built (Alt. Source) 1967	Est. Decade Built 1960
Total Area (square ft) 192822	Number of Stories 1	Basement	Pounding Potential No
Plan Irregularities Out of Plane Lateral-Force-Resistance Elements None None		Vertical Irregularities None None None	
Falling Hazards None None None		Poor Conditions None None None

N Plan Irregularity Primary

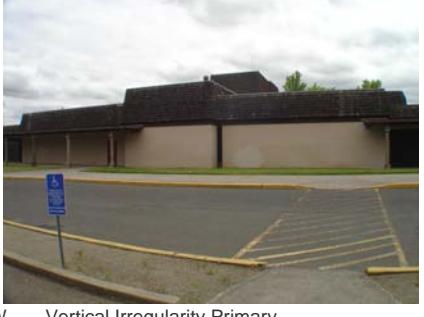
High (>10%)

Enrollment 1941	Year Built (Field Verified) 1967	Year Built (Alt. Source) 1967	Est. Decade Built 1960
Total Area (square ft) 192822	Number of Stories 1	Basement	Pounding Potential No
Plan Irregularities		Vertical Irregularities	
Out of Plane Lateral-Force-Resistance Elements		Steps in Elevation View: Very Irregular Changes	
Reentrant Corners: Other		None	
None		None	
Falling Hazards		Poor Conditions	
None		None	
None		None	
None		None

W Vertical Irregularity Primary
