Orchard Hill Elementary School

Phoenix-Talent SD 4

FEMA 154 Rapid Visual Screening Score Card

Rapid Visual Screening - Senate Bill #2 - Seismic Needs Assessment
Oregon Department of Geology and Mineral Industries

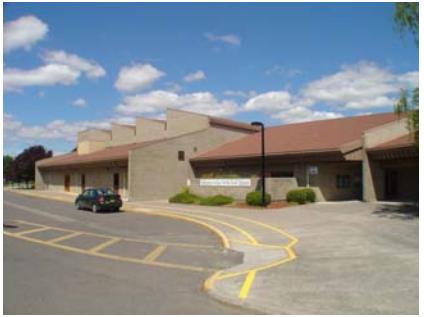
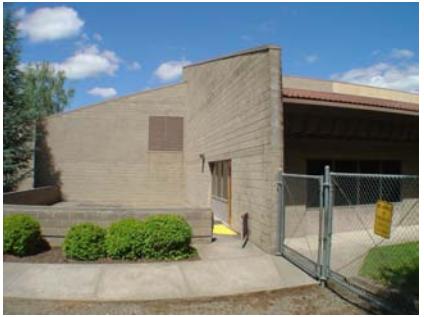
W Elevation View	S Elevation View non-parallel lateral system.	S Vertical Irregularity Primary

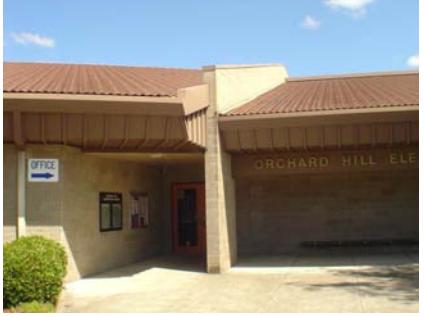
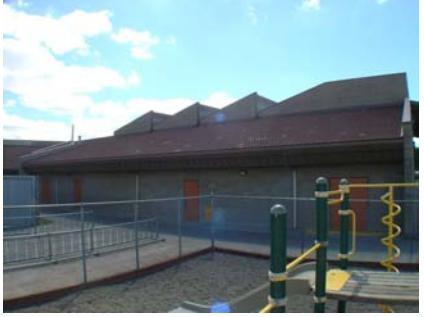
W Vertical Irregularity Primary	E Elevation View	E Elevation View
