Wilson Elementary School

Medford SD 549C

FEMA 154 Rapid Visual Screening Score Card

Rapid Visual Screening - Senate Bill #2 - Seismic Needs Assessment
 Oregon Department of Geology and Mineral Industries

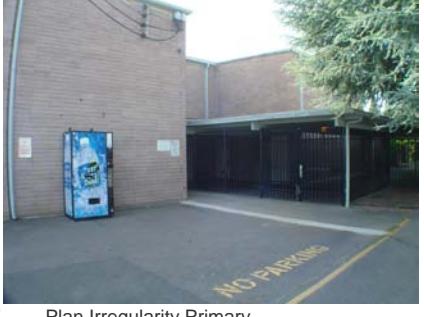
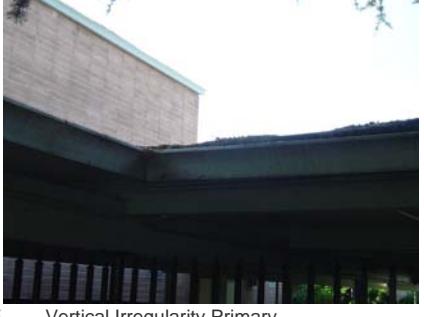
Enrollment 572	Year Built (Field Verified) 1958	Year Built (Alt. Source) 1958	Est. Decade Built 1950
Total Area (square ft) 44204	Number of Stories 1	Basement	Pounding Potential No
Plan Irregularities Reentrant Corners: Other None None		Vertical Irregularities Steps in Elevation View: 2 to 3 Changes (Adjacent Building/Entity) None None	
Falling Hazards None None None		Poor Conditions None None None

E Plan Irregularity Primary		E Vertical Irregularity Primary

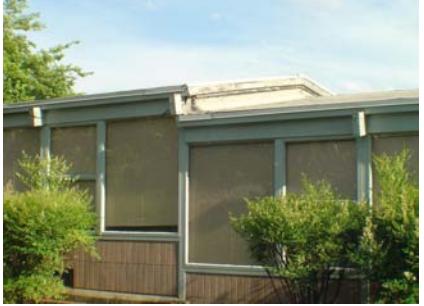
High (>10%)

Enrollment 572	Year Built (Field Verified) 1958	Year Built (Alt. Source) 1950	Est. Decade Built 1950
Total Area (square ft) 44204	Number of Stories 1	Basement	Pounding Potential No
Plan Irregularities None None None		Vertical Irregularities Steps in Elevation View: Single Change None None	
Falling Hazards None None None		Poor Conditions None None None

N Vertical Irregularity Primary

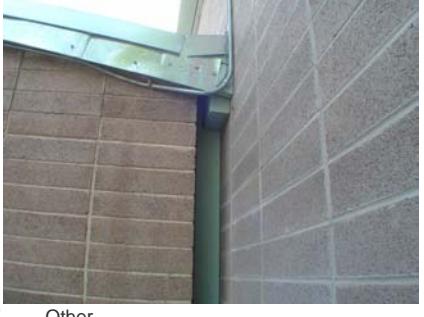
Enrollment 572	Year Built (Field Verified) 1958	Year Built (Alt. Source) 1958	Est. Decade Built 1950
Total Area (square ft) 44204	Number of Stories 1	Basement	Pounding Potential Yes
Plan Irregularities None None None		Vertical Irregularities None None None	
Falling Hazards None None None		Poor Conditions None None None

E Other Joint to "E"

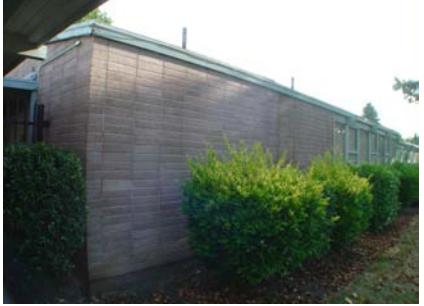
NE Elevation View

High (>10%)

Enrollment 572	Year Built (Field Verified) 1958	Year Built (Alt. Source) 1950	Est. Decade Built 1950
Total Area (square ft) 44204	Number of Stories 1	Basement	Pounding Potential No
Plan Irregularities None None None		Vertical Irregularities Steps in Elevation View: 2 to 3 Changes None None	
Falling Hazards None None None		Poor Conditions None None None
