Little Butte School

Jack_sch44A

FEMA 154 Rapid Visual Screening Score Card

Rapid Visual Screening - Senate Bill #2 - Seismic Needs Assessment
Oregon Department of Geology and Mineral Industries

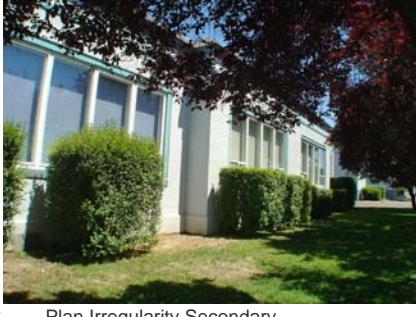
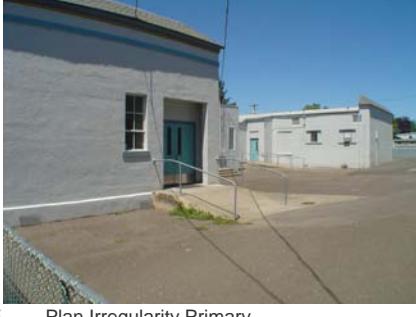
Enrollment 462	Year Built (Field Verified) 1950	Year Built (Alt. Source) 1950	Est. Decade Built 1920
Total Area (square ft) 44760	Number of Stories 1	Basement	Pounding Potential No
Plan Irregularities		Vertical Irregularities	
Reentrant Corners: Other		None	
Out of Plane Lateral-Force-Resistance Elements		None	
None		None	
Falling Hazards		Poor Conditions	
None		None	
None		None	
None		None

S	Plan Irregularity Secondary	E	Plan Irregularity Primary

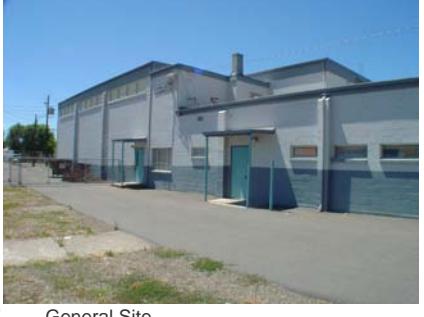
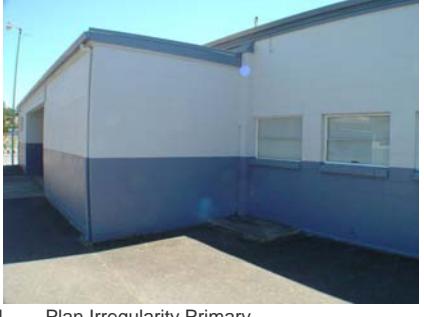
Enrollment 462	Year Built (Field Verified) 1950	Year Built (Alt. Source) 1950	Est. Decade Built 1950
Total Area (square ft) 44760	Number of Stories 1	Basement	Pounding Potential No
Plan Irregularities Reentrant Corners: Other None None		Vertical Irregularities Steps in Elevation View: 2 to 3 Changes None None	
Falling Hazards None None None		Poor Conditions None None None

E General Site		N Plan Irregularity Primary

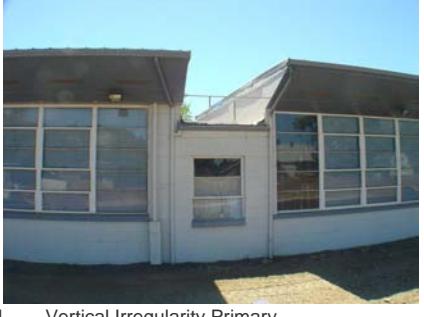
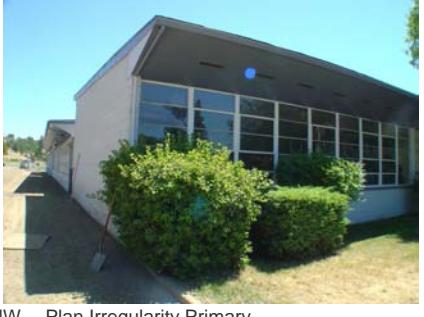
Enrollment 462	Year Built (Field Verified) 1950	Year Built (Alt. Source) 1950	Est. Decade Built 1950
Total Area (square ft) 44760	Number of Stories 1	Basement	Pounding Potential No
Plan Irregularities Torsion: Eccentric Stiffness None None		Vertical Irregularities Steps in Elevation View: Single Change None None	
Falling Hazards None None None		Poor Conditions None None None

N Vertical Irregularity Primary		NW Plan Irregularity Primary

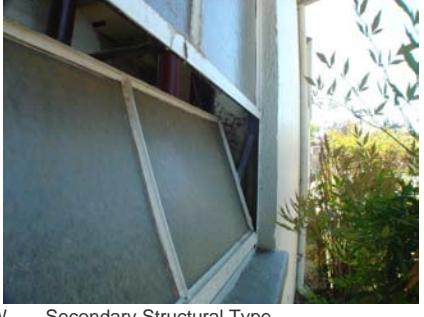
W Secondary Structural Type
