Shady Cove School

Eagle Point SD 9

Jack_sch45A

Rapid Visual Screening - Senate Bill #2 - Seismic Needs Assessment
Oregon Department of Geology and Mineral Industries

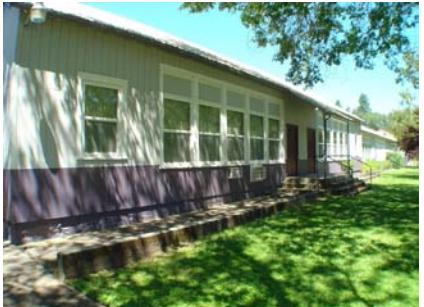
SE General Site	E Vertical Irregularity Primary	N Vertical Irregularity Primary

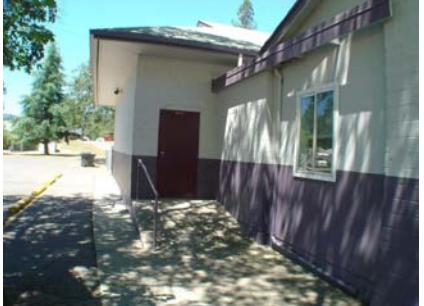
S Plan Irregularity Secondary	W Plan Irregularity Primary	S General Site

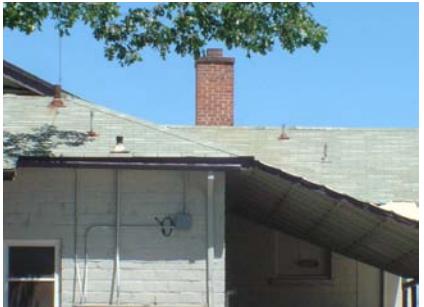
S Falling Hazard
