# Mountain View Hospital - Madras

Jeff\_hos01A

## FEMA 154 Rapid Visual Screening Score Card

Rapid Visual Screening - Senate Bill #2 - Seismic Needs Assessment  
Oregon Department of Geology and Mineral Industries

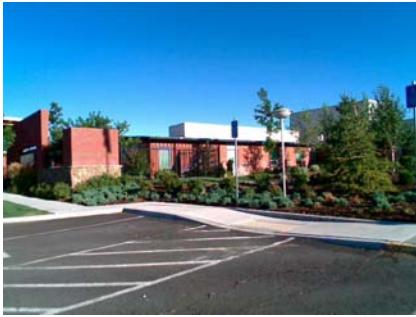
SE Elevation View		NE Elevation View

Enrollment	Year Built (Field Verified)	Year Built (Alt. Source)	Est. Decade Built
		1967	1970
Total Area (square ft)	Number of Stories	Basement	Pounding Potential
	1	No	No
Plan Irregularities		Vertical Irregularities	
Reentrant Corners:Other (Adjacent Build/Entity)		Steps in Elevation View: Very Irregular Changes (Adjacent Building/Ent)	
Reentrant Corners: Other		Steps in Elevation View: Very Irregular Changes	
None		None	
Falling Hazards		Poor Conditions	
None		None	
None		None	
None		None

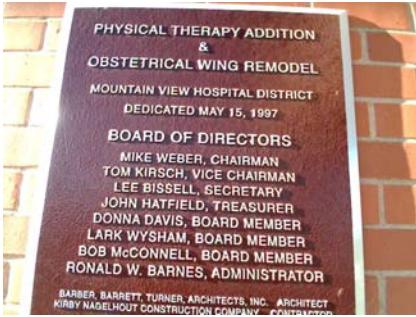
N Other	
1197 additon to jeff_ho01a including a remodel of a large portion of it.

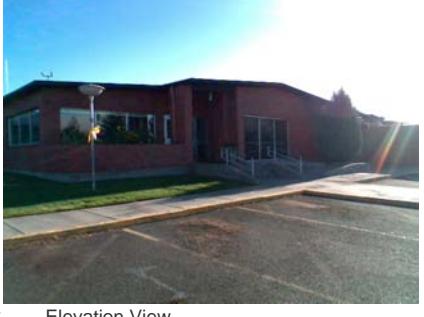
S	Elevation View	NW	Elevation View

Enrollment	Year Built (Field Verified)	Year Built (Alt. Source)	Est. Decade Built
		1967	1980
Total Area (square ft)	Number of Stories	Basement	Pounding Potential
	1	No	No
Plan Irregularities		Vertical Irregularities	
Reentrant Corners:Other (Adjacent Build/Entity)		Steps in Elevation View: 2 to 3 Changes (Adjacent Building/Entity)	
Reentrant Corners: Other		None	
None		None	
Falling Hazards		Poor Conditions	
None		None	
None		None	
None		None

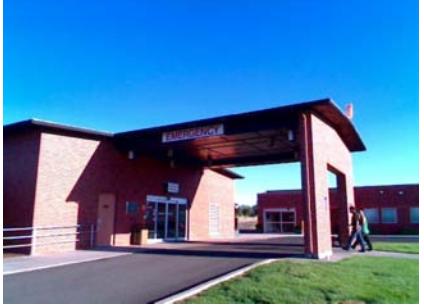
SE General Site		SE Falling Hazard

Enrollment	Year Built (Field Verified)	Year Built (Alt. Source)	Est. Decade Built
	1989	1967	1980
Total Area (square ft)	Number of Stories	Basement	Pounding Potential
	1	No	No
Plan Irregularities		Vertical Irregularities	
Reentrant Corners:Other (Adjacent Build/Entity)		Steps in Elevation View: Single Change (Adjacent Building/Entity)	
Reentrant Corners: Other		None	
None		None	
Falling Hazards		Poor Conditions	
Other: Ornamental Hazard Over Exit		None	
None		None	
None		None
