Riverside - K Building

Rogue CC

FEMA 154 Rapid Visual Screening Score Card

Rapid Visual Screening - Senate Bill #2 - Seismic Needs Assessment
Oregon Department of Geology and Mineral Industries

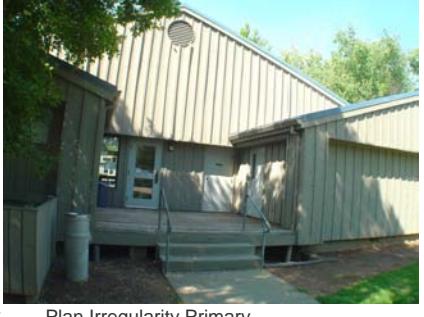
| Reentrant Corners: Other | | Steps in Elevation View: 2 to 3 Changes | |
| S | Plan Irregularity Primary | S | Vertical Irregularity Primary |
