Madrona Elementary School

Three Rivers/Josephine County SD

FEMA 154 Rapid Visual Screening Score Card

Rapid Visual Screening - Senate Bill #2 - Seismic Needs Assessment
Oregon Department of Geology and Mineral Industries

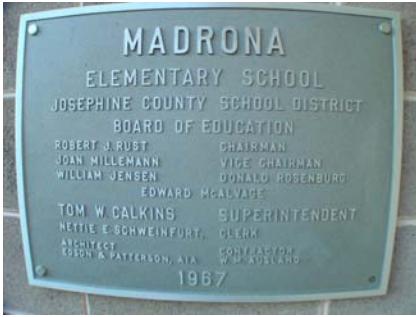
N Field Verified Year Built

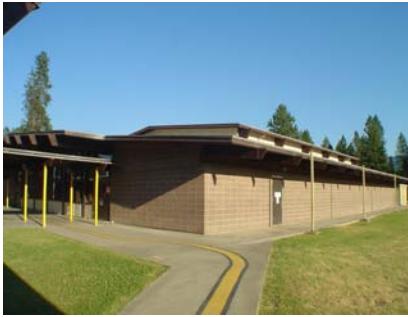
NW Primary Structural Type

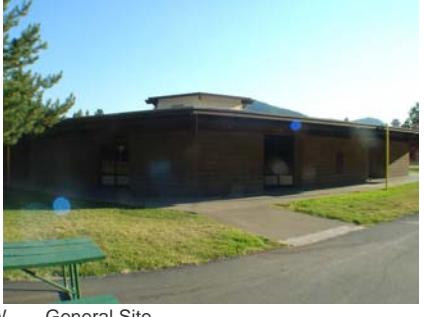
W General Site

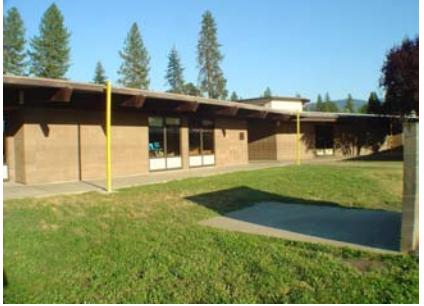
Enrollment 299	Year Built (Field Verified) 1967	Year Built (Alt. Source) 1967	Est. Decade Built 1960
Total Area (square ft) 37816	Number of Stories 1	Basement	Pounding Potential No
Plan Irregularities Non-Parallel System Reentrant Corners: Other (Adjacent Build/Entity) None		Vertical Irregularities None None None	
Falling Hazards None None None		Poor Conditions None None None

W Plan Irregularity Secondary

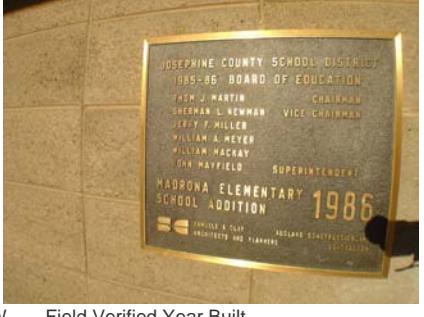
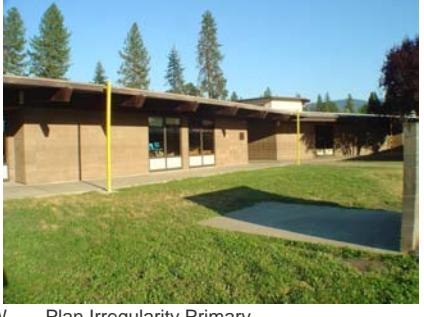
Enrollment 299	Year Built (Field Verified) 1986	Year Built (Alt. Source) 1967	Est. Decade Built 1980
Total Area (square ft) 37816	Number of Stories 1	Basement	Pounding Potential No
Plan Irregularities Reentrant Corners:Other (Adjacent Build/Entity) None None		Vertical Irregularities None None None	
Falling Hazards None None None		Poor Conditions None None None

W Field Verified Year Built	W Plan Irregularity Primary
