# Merrill RFPD

Klam\_fir16A

| RVS in 2006 | | 7/21/2006 | |

Rapid Visual Screening - Senate Bill #2 - Seismic Needs Assessment  
Oregon Department of Geology and Mineral Industries

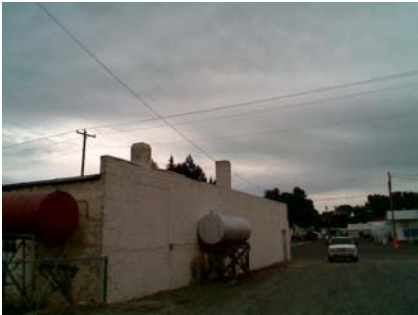
| Unreinforced Chimneys | None |

S Falling Hazard

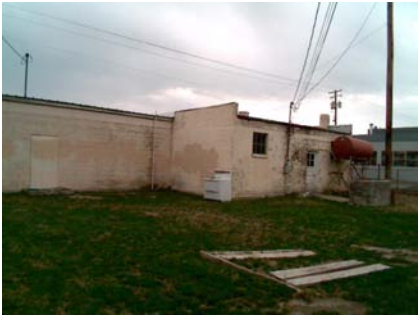
| Torsion: Eccentric Stiffness | None |
| Reentrant Corners: L Shaped | None |

W Plan Irregularity Secondary
