Merle West Medical Center - Klamath Falls

Klam_hos01A

Building Type	County	
Hospital	Klamath	
Street		
2865 Daggett Ave		
City	State	Zip
Klamath Falls	OR	97601
Latitude	Longitude	
42.25316	121.78483	
Tracking Code	Inspection Date	
New Building	7/20/2006

Rapid Visual Screening - Senate Bill #2 - Seismic Needs Assessment
Oregon Department of Geology and Mineral Industries

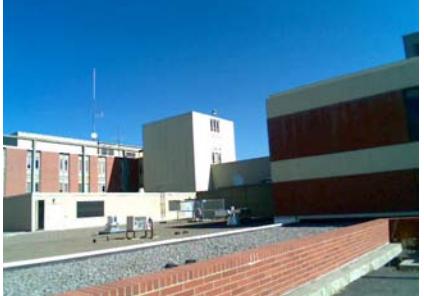
SE Plan Irregularity Primary		NE Vertical Irregularity Secondary

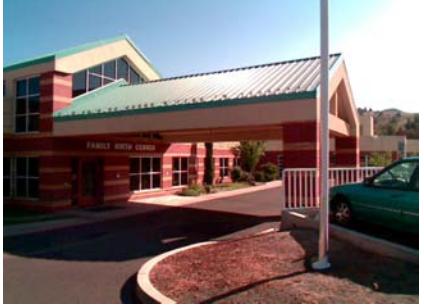
Enrollment	Year Built (Field Verified)	Year Built (Alt. Source)	Est. Decade Built
			1980
Total Area (square ft)	Number of Stories	Basement	Pounding Potential
	1	No	No
Plan Irregularities		Vertical Irregularities	
Reentrant Corners: Other		Steps in Elevation View: Very Irregular Changes	
None		Steps in Elevation View: 2 to 3 Changes (Adjacent Building/Entity)	
None		None	
Falling Hazards		Poor Conditions	
Other: Ornamental Hazard Over Exit		None	
None		None	
None		None

S	Falling Hazard	SE	Plan Irregularity Primary

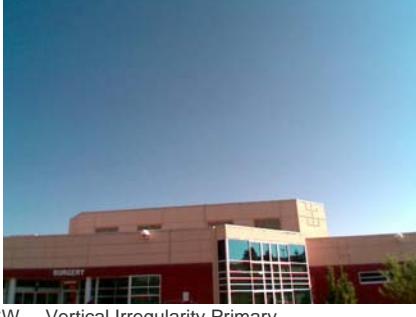
SW Vertical Irregularity Primary		E Plan Irregularity Secondary
