Fairhaven Elementary School

Klamath County SD

FEMA 154 Rapid Visual Screening Score Card

Rapid Visual Screening - Senate Bill #2 - Seismic Needs Assessment
Oregon Department of Geology and Mineral Industries

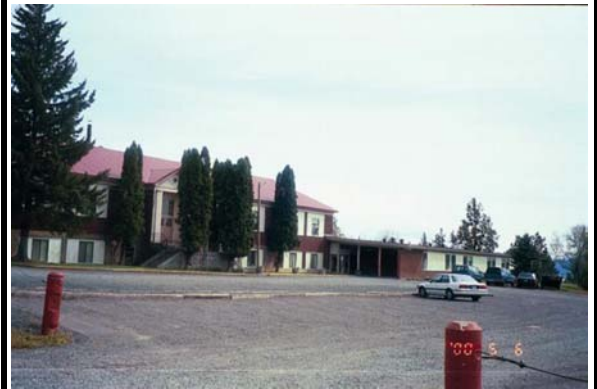
FEMA-154 Collapse Potential

High (>10%)
