Mazama High School

Klamath Falls City Schools

Klam_sch18A

Rapid Visual Screening - Senate Bill #2 - Seismic Needs Assessment
Oregon Department of Geology and Mineral Industries

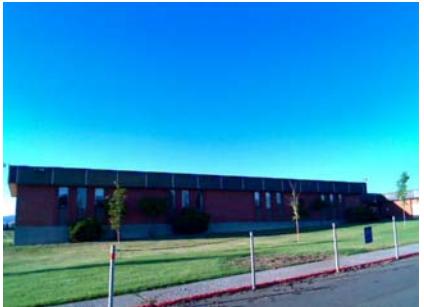
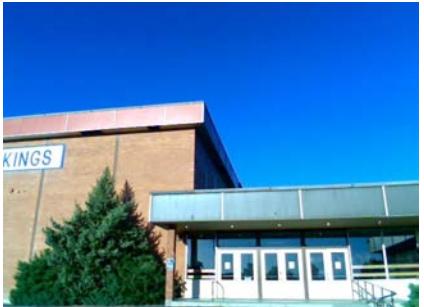
S General Site	W Vertical Irregularity Primary	N Vertical Irregularity Primary

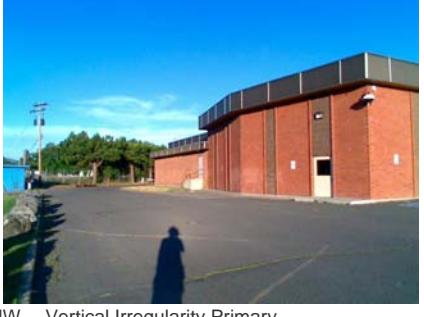
NW Vertical Irregularity Primary

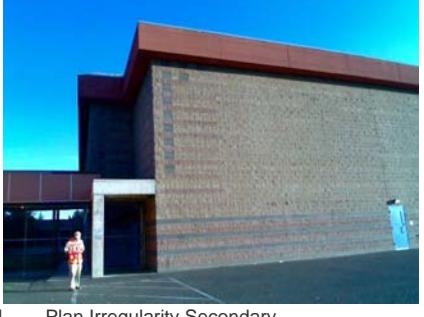
N Plan Irregularity Secondary
