Ponderosa Junior High School

Klamath Falls City Schools

FEMA 154 Rapid Visual Screening Score Card

Rapid Visual Screening - Senate Bill #2 - Seismic Needs Assessment
Oregon Department of Geology and Mineral Industries

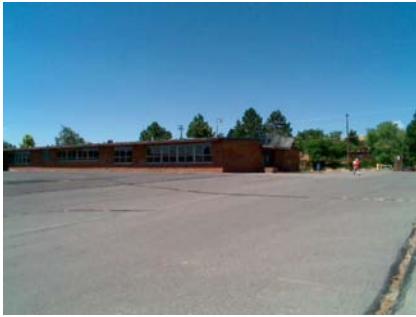
Enrollment 478	Year Built (Field Verified) 1945	Year Built (Alt. Source) 1940	Est. Decade Built 1940
Total Area (square ft) 84435	Number of Stories 1	Basement	Pounding Potential No
Plan Irregularities Reentrant Corners:L shaped (Adjacent Build/Entity) None None		Vertical Irregularities Steps in Elevation View: Single Change (Adjacent Building/Entity) None None	
Falling Hazards Other: Ornamental Hazard Over Exit None None		Poor Conditions None None None

SE Falling Hazard

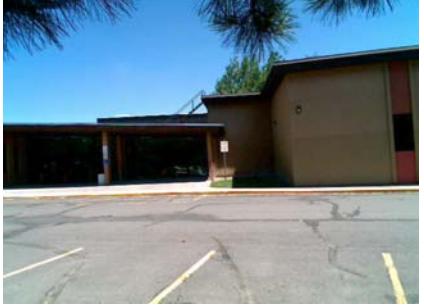
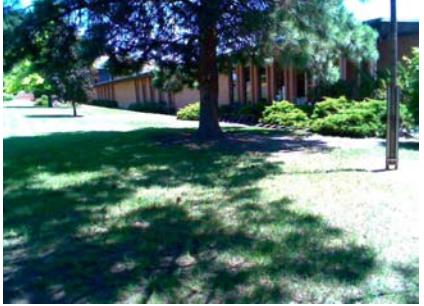
Enrollment 478	Year Built (Field Verified) 1945	Year Built (Alt. Source) 1945	Est. Decade Built 1960
Total Area (square ft) 84435	Number of Stories 1	Basement	Pounding Potential No
Plan Irregularities Reentrant Corners:Other (Adjacent Build/Entity) None None		Vertical Irregularities Steps in Elevation View: 2 to 3 Changes (Adjacent Building/Entity) None None	
Falling Hazards None None None		Poor Conditions None None None

W Vertical Irregularity Primary		S General Site

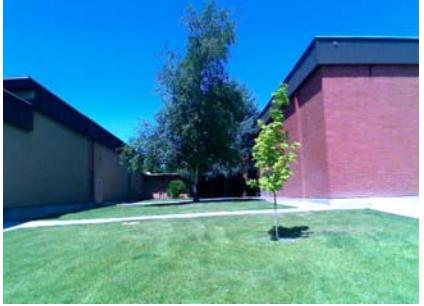
Enrollment 478	Year Built (Field Verified) 1945	Year Built (Alt. Source) 1945	Est. Decade Built 1970
Total Area (square ft) 84435	Number of Stories 1	Basement	Pounding Potential No
Plan Irregularities Reentrant Corners:Other (Adjacent Build/Entity) None None		Vertical Irregularities Steps in Elevation View: 2 to 3 Changes (Adjacent Building/Entity) None None	
Falling Hazards None None None		Poor Conditions None None None

S Plan Irregularity Primary

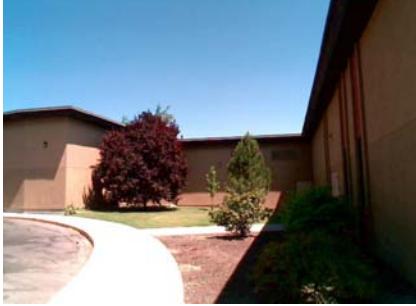
Enrollment 478	Year Built (Field Verified) 1945	Year Built (Alt. Source) 1945	Est. Decade Built 1990
Total Area (square ft) 84435	Number of Stories 1	Basement	Pounding Potential No
Plan Irregularities Reentrant Corners: Other Reentrant Corners: Other None		Vertical Irregularities Steps in Elevation View: 2 to 3 Changes (Adjacent Building/Entity) Steps in Elevation View: Single Change None	
Falling Hazards None None None		Poor Conditions None None None

W Plan Irregularity Primary
