# Fairview Elementary School

Klamath Falls City Schools

Klam\_sch22A

## FEMA 154 Rapid Visual Screening Score Card

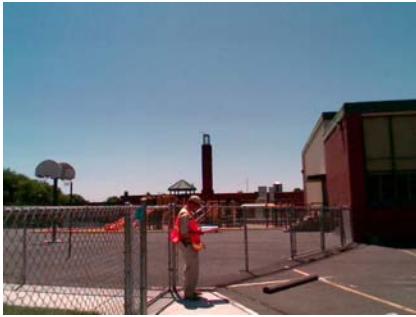
N Falling Hazard
