Joseph Conger Elementary School

Klamath Falls City Schools

FEMA 154 Rapid Visual Screening Score Card

Rapid Visual Screening - Senate Bill #2 - Seismic Needs Assessment
Oregon Department of Geology and Mineral Industries

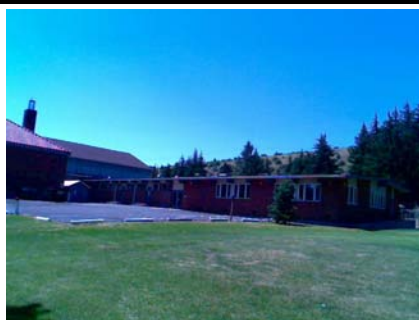
NE Plan Irregularity Primary
