# Christmas Valley RFPD

Lake\_fir01A

## FEMA 154 Rapid Visual Screening Score Card

Rapid Visual Screening - Senate Bill #2 - Seismic Needs Assessment  
Oregon Department of Geology and Mineral Industries

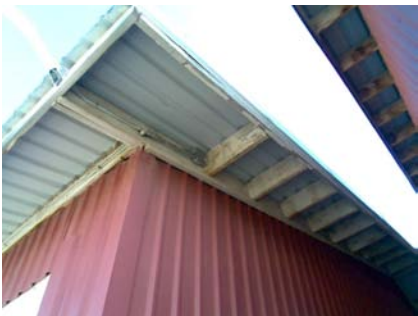
S Primary Structural Type

| Torsion: Eccentric Stiffness | None |

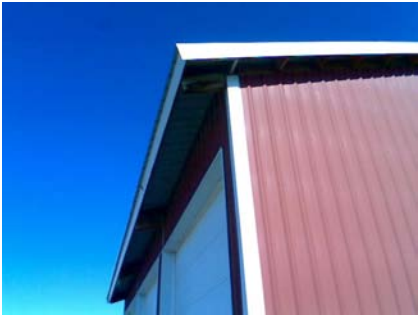
S Primary Structural Type

| Torsion: Eccentric Stiffness | None |
