Lake District Hospital - Lakeview

Lake_hos01A

FEMA 154 Rapid Visual Screening Score Card

Rapid Visual Screening - Senate Bill #2 - Seismic Needs Assessment
Oregon Department of Geology and Mineral Industries

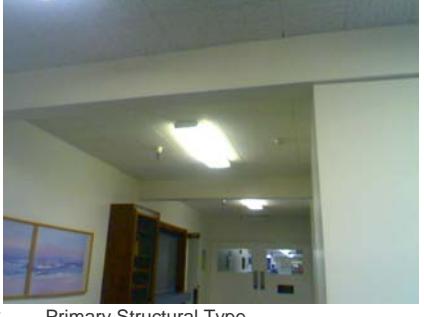
S Primary Structural Type looks like wood beams inside	S Primary Structural Type wood beams coming from inside going outside.	E Primary Structural Type wood beams

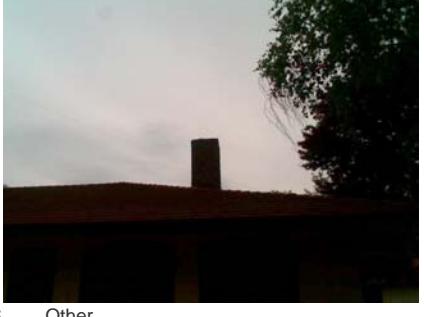
S General Site	S Other smokestack	S General Site

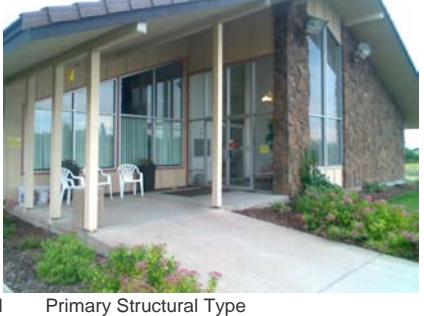
W General Site	N Primary Structural Type wood post and beams	N General Site
