# Paisley School

Paisley SD 11

Lake\_sch01A

Rapid Visual Screening - Senate Bill #2 - Seismic Needs Assessment  
Oregon Department of Geology and Mineral Industries

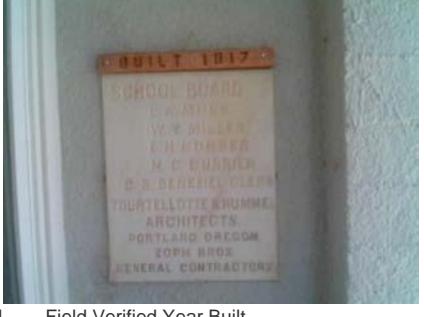
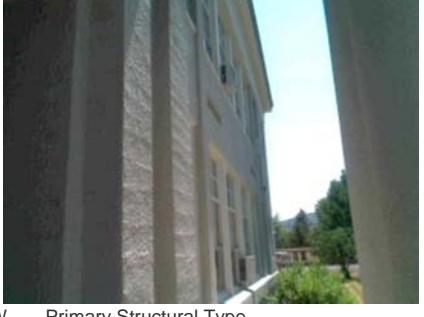
| Plan Irregularities<br>None<br>None<br>None | | Vertical Irregularities<br>Steps in Elevation View: Single Change<br>Internal Discontinuous Diaphragm (large internal opening)<br>None | |
| N | Field Verified Year Built | W | Primary Structural Type |

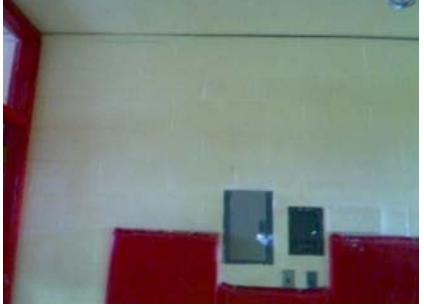
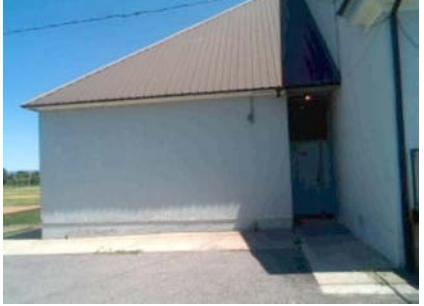
| <br>S Primary Structural Type | | <br>W Elevation View | |

| Plan Irregularities<br>Reentrant Corners:Other (Adjacent Build/Entity)<br>None<br>None | | Vertical Irregularities<br>Steps in Elevation View: Single Change (Adjacent Building/Entity)<br>None<br>None | |
