Fremont/Hay Elementary School

Lake County SD 7

FEMA 154 Rapid Visual Screening Score Card

Rapid Visual Screening - Senate Bill #2 - Seismic Needs Assessment
Oregon Department of Geology and Mineral Industries

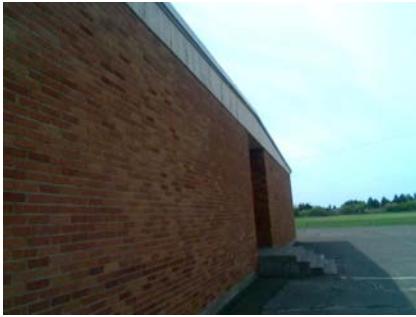
W Elevation View		N Elevation View

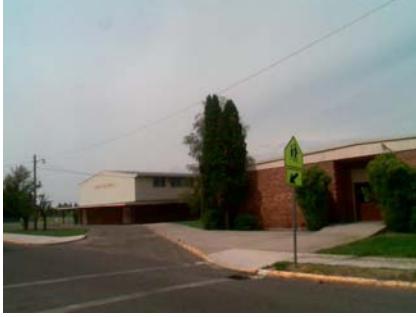
E General Site		N Primary Structural Type
