Branch - Florence Center

Lane CC

Building Type Community_College	County Lane	
Street 3149 Oak St		
City Florence	State OR	Zip 97439
Latitude 43.99414	Longitude 124.10483	
Tracking Code RVS in 2006	Inspection Date 8/4/2006

Rapid Visual Screening - Senate Bill #2 - Seismic Needs Assessment
Oregon Department of Geology and Mineral Industries

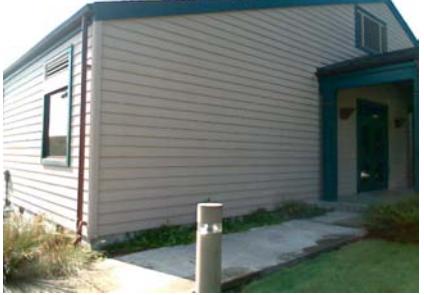
NW Primary Structural Type W2		NW General Site

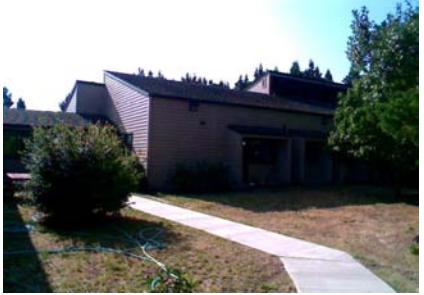
NW Plan Irregularity Primary Reentrant Corner and vertical irregularity.

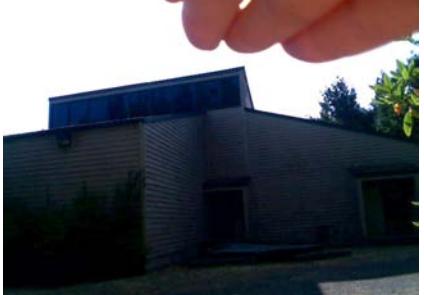
W Plan Irregularity Primary Reentrant corner and a vertical irregularity.		E General Site
