# Lake Creek Fire & Rescue

Lane\_fir10A

## FEMA 154 Rapid Visual Screening Score Card

Rapid Visual Screening - Senate Bill #2 - Seismic Needs Assessment  
Oregon Department of Geology and Mineral Industries

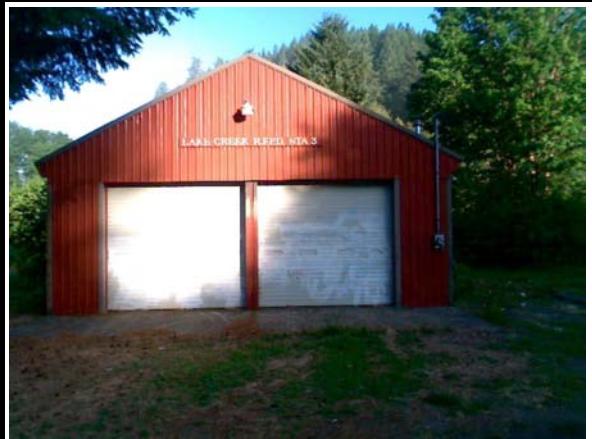
Type	Basic Score	Vert Irreg	Plan Irreg	Pre-Code	Post-Bench	Soil C	Soil D	Soil E	RVS Score
Primary	S3	3.2	0	0	0	0	0	-0.6	0	2.6
Secondary		0	0	0	0	0	0	0	0	0
Tertiary		0	0	0	0	0	0	0	0	0

Final Type	Final Score
S3	2.6

Low (<1%)
