# Creswell Station

Building Type Fire - RFPD	County Lane	
Street 55 1st St		
City Creswell	State OR	Zip 97426
Latitude 43.91742	Longitude 123.02024	
Tracking Code RVS in 2006	Inspection Date 7/21/2006

Rapid Visual Screening - Senate Bill #2 - Seismic Needs Assessment  
Oregon Department of Geology and Mineral Industries

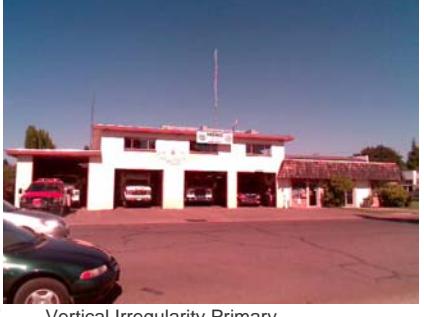
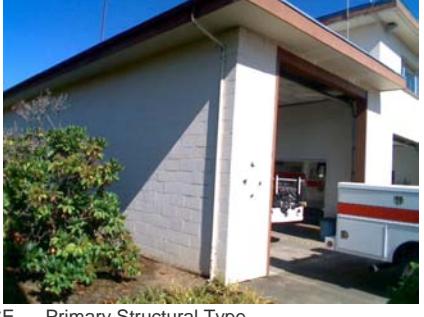
E	Vertical Irregularity Primary	SE	Primary Structural Type

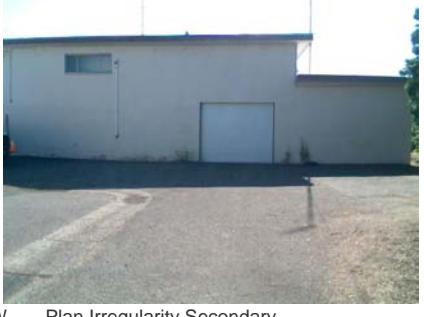
<p>W Plan Irregularity Secondary shows an almost solid wall opposite the front wall which has large openings. Indicating possible torsion problems.</p>

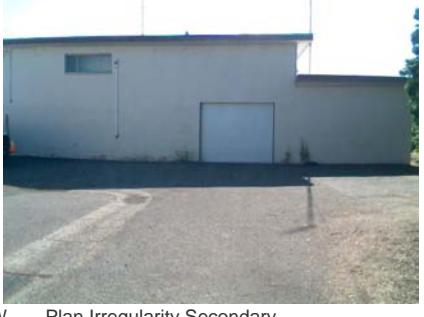
<p>W Plan Irregularity Primary due to police station.</p>
