Siuslaw Valley F & R

Lane_fir14A

FEMA 154 Rapid Visual Screening Score Card

Rapid Visual Screening - Senate Bill #2 - Seismic Needs Assessment
Oregon Department of Geology and Mineral Industries

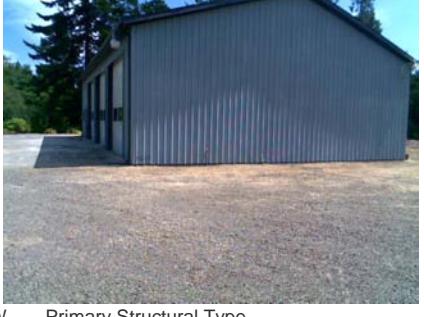
W	Primary Structural Type	SW	Plan Irregularity Primary Shows that the back wall is solid indicating a potential torsion problem.
