Lane Rural Fire Rescue - Station 54 Alderwood

Lane_fir16A

FEMA 154 Rapid Visual Screening Score Card

Rapid Visual Screening - Senate Bill #2 - Seismic Needs Assessment
Oregon Department of Geology and Mineral Industries

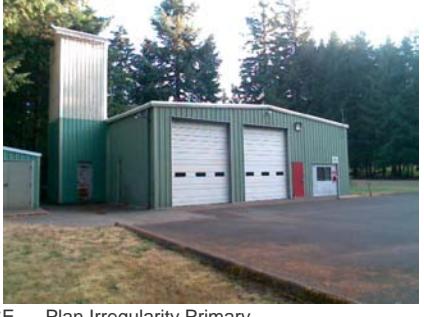
| <p>SE Plan Irregularity Primary also shows vertical irregularity.</p> | | | |
