Mckenzie Fire & Rescue

Lane_fir24A

Building Type Fire - RFPD	County Lane	
Street 49243 Mckenzie Highway		
City Vida	State OR	Zip 97488
Latitude 44.1115	Longitude 122.43265	
Tracking Code RVS in 2006	Inspection Date 7/20/2006

Rapid Visual Screening - Senate Bill #2 - Seismic Needs Assessment
Oregon Department of Geology and Mineral Industries

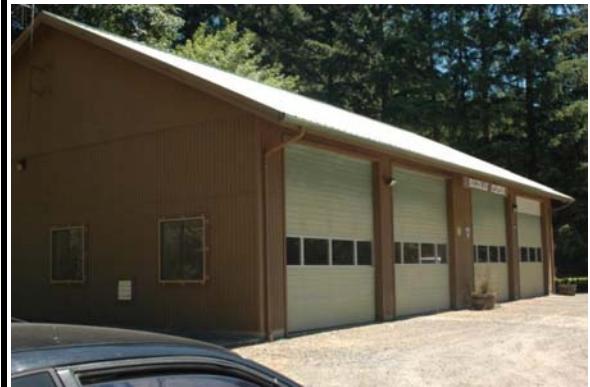
Seismicity Zone: Moderate										
FEMA 154 Rapid Visual Screening Score Card										
	Type	Basic Score	Vert Irreg	Plan Irreg	Pre-Code	Post-Bench	Soil C	Soil D	Soil E	RVS Score
Primary	W2	4.8	0	-0.5	0	1.6	-0.8	0	0	5.1
Secondary		0	0	0	0	0	0	0	0	0
Tertiary		0	0	0	0	0	0	0	0	0

Final Type	Final Score
W2	5.1

Low (<1%)

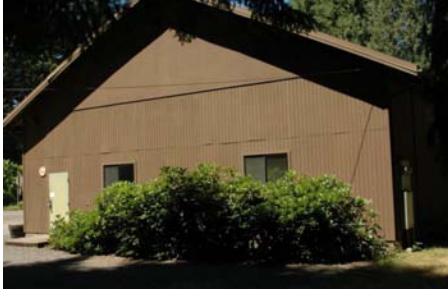
SE Primary Structural Type

Enrollment	Year Built (Field Verified)	Year Built (Alt. Source)	Est. Decade Built
			1980
Total Area (square ft)	Number of Stories	Basement	Pounding Potential
	1	No	No
Plan Irregularities		Vertical Irregularities	
Torsion: Eccentric Stiffness		None	
None		None	
None		None	
Falling Hazards		Poor Conditions	
None		None	
None		None	
None		None
