South Lane County F&R

Lane_fir28A

FEMA 154 Rapid Visual Screening Score Card

Rapid Visual Screening - Senate Bill #2 - Seismic Needs Assessment
Oregon Department of Geology and Mineral Industries

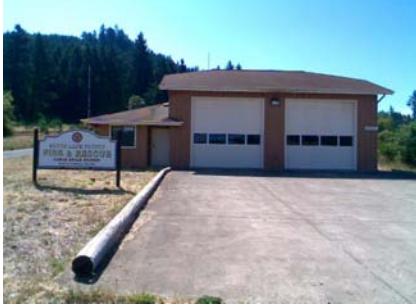
| N Vertical Irregularity Primary | | SE Plan Irregularity Primary shows the back wall of the station is solid indicating a potential torsion problem. | |
