# Swisshome-Deadwood RFPD

Lane\_fir41A

## FEMA 154 Rapid Visual Screening Score Card

Rapid Visual Screening - Senate Bill #2 - Seismic Needs Assessment  
Oregon Department of Geology and Mineral Industries

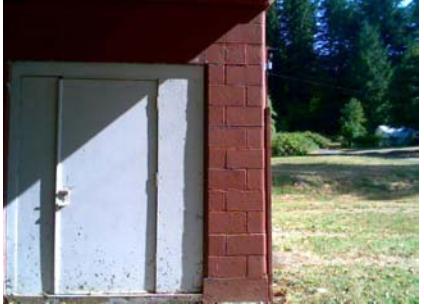
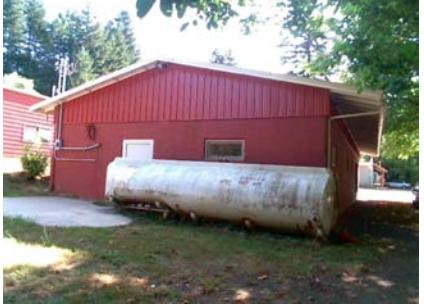
S	Primary Structural Type	W	Primary Structural Type and secondary structural type.

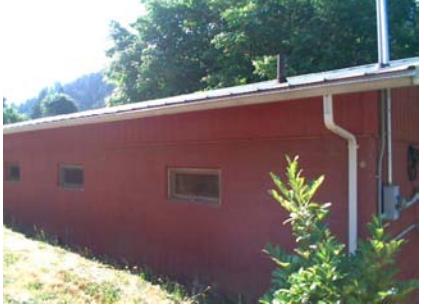
NE	General Site

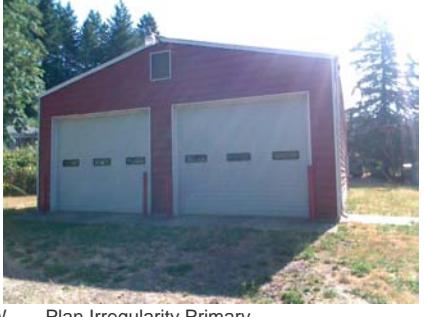
W	Plan Irregularity Primary
