# Swisshome - Deadwood RFPD Station 2

## FEMA 154 Rapid Visual Screening Score Card

Rapid Visual Screening - Senate Bill #2 - Seismic Needs Assessment  
Oregon Department of Geology and Mineral Industries

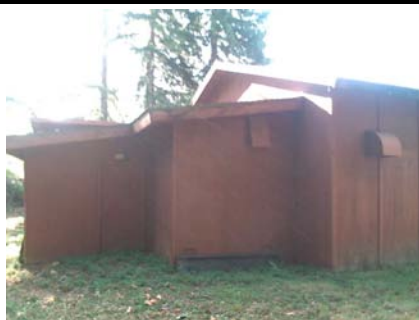
W Plan Irregularity Primary  
also shows a vertical irregularity.

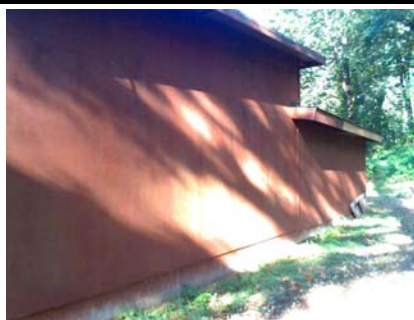
N Vertical Irregularity Primary  
Also shows the back wall of the building is solid indicating a potential torsion problem.
