Sacred Heart Medical Center - Eugene

Lane_hos03A

Street 1255 Hilyard St		
City Eugene	State OR	Zip 97401
Latitude 44.04699	Longitude 123.08114	
Tracking Code New Building	Inspection Date 7/20/2006

Rapid Visual Screening - Senate Bill #2 - Seismic Needs Assessment
Oregon Department of Geology and Mineral Industries

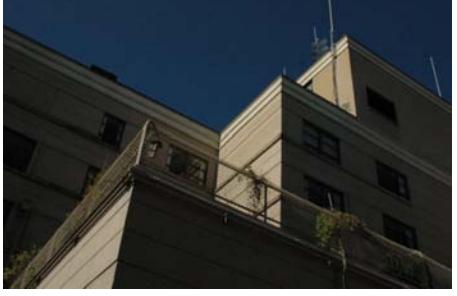
NE Plan Irregularity Primary and more vertical irr.		E Falling Hazard reinforced chimney?

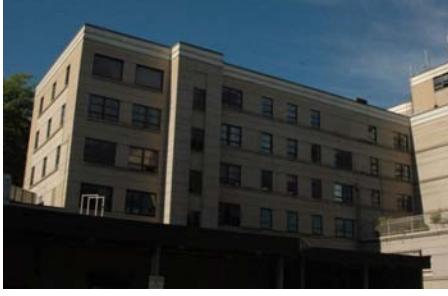
NE General Site

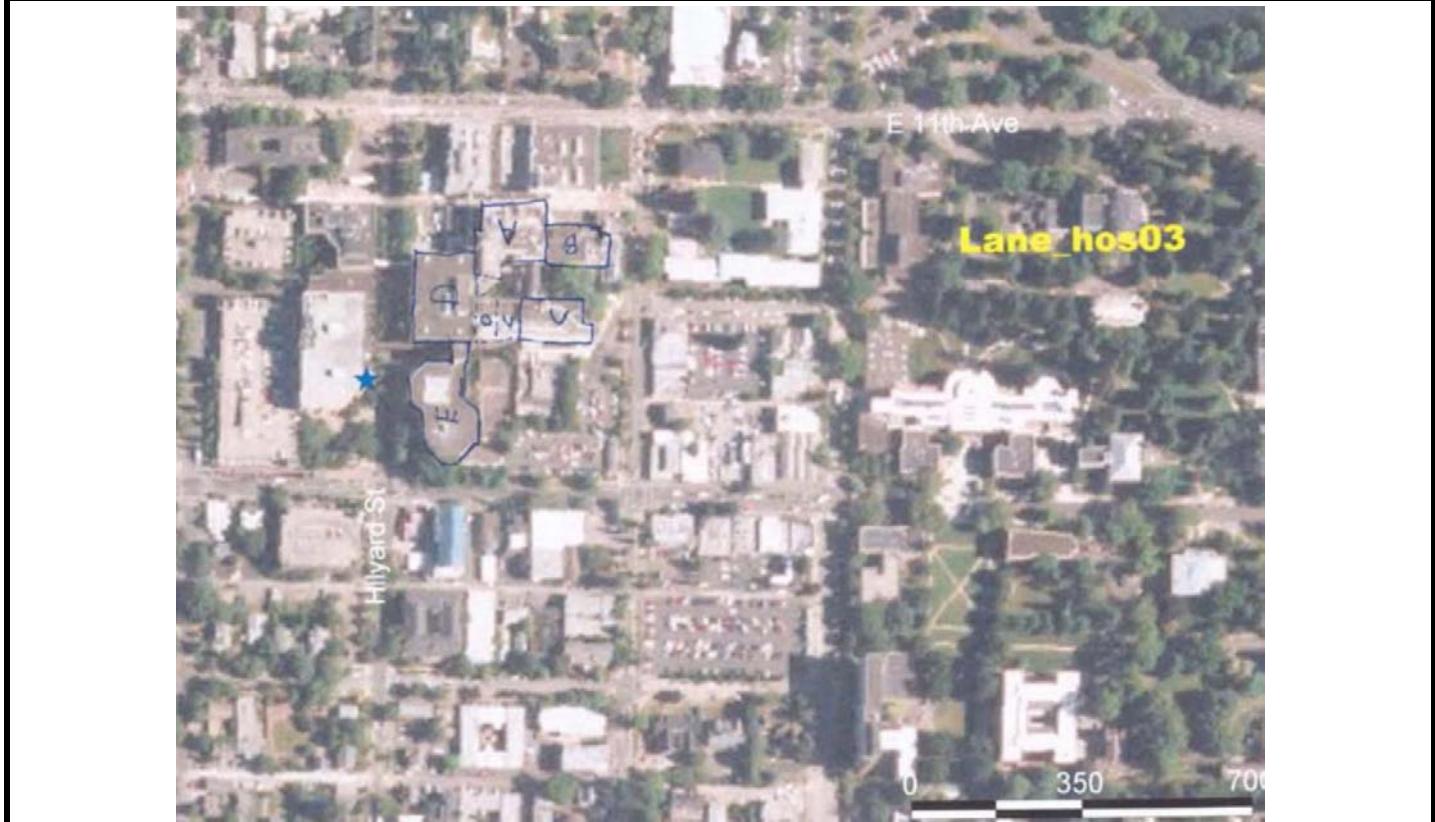
NE	Plan Irregularity Primary

S Pounding Potential pounding potential -- joint that is potentially not large enough for seismic isolation.			SE Vertical Irregularity Primary

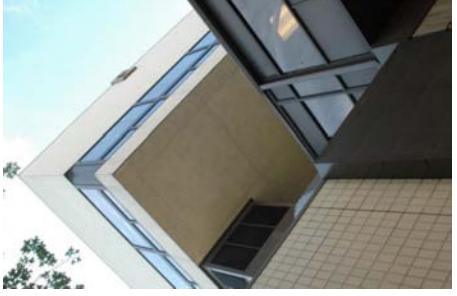
W Vertical Irregularity Primary cantilever portions		W Vertical Irregularity Primary cantilever portions

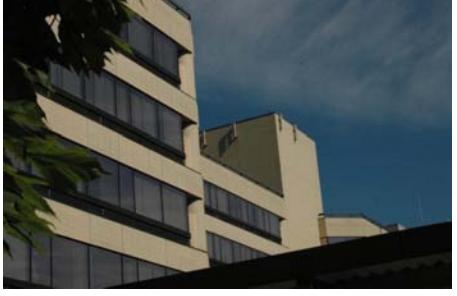
SE Vertical Irregularity Primary		SW Plan Irregularity Primary non-parallel
