Edison Elementary School

Eugene SD 4J

FEMA 154 Rapid Visual Screening Score Card

Rapid Visual Screening - Senate Bill #2 - Seismic Needs Assessment
Oregon Department of Geology and Mineral Industries

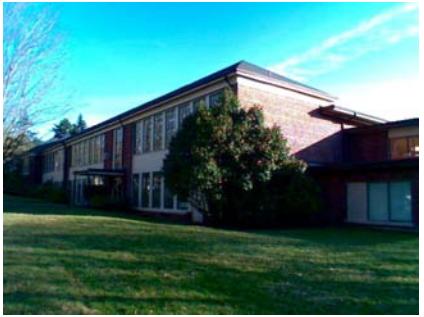
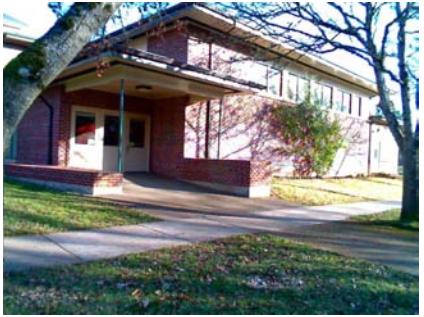
NW Plan Irregularity Primary		W Secondary Structural Type

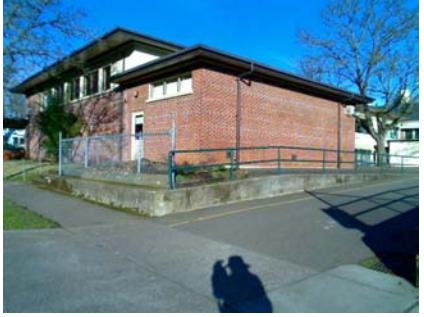
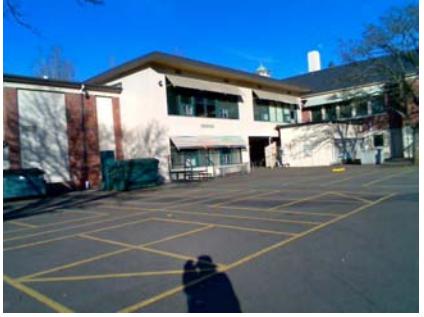
SW Vertical Irregularity Primary		S Primary Structural Type

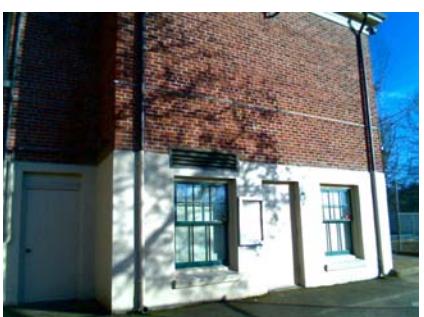
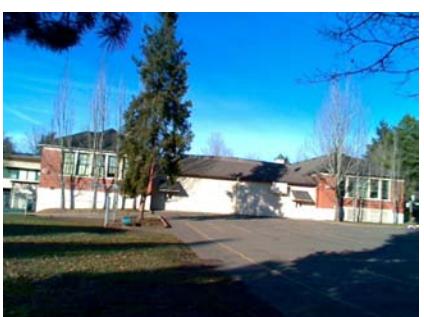
W Primary Structural Type		S Elevation View wood infill area between brick wings

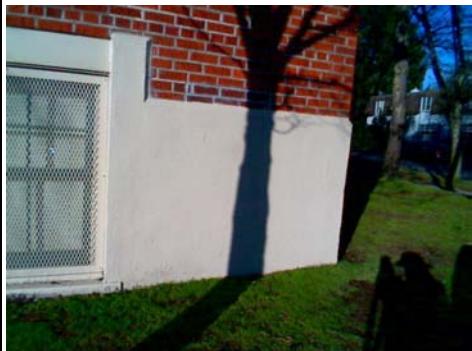
S Primary Structural Type

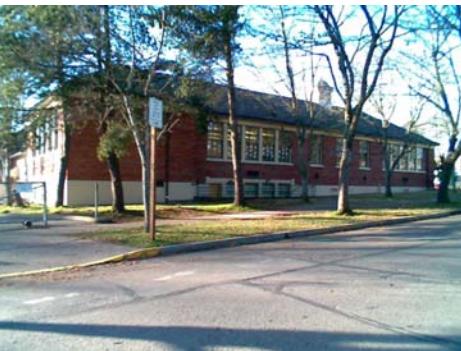
SE Elevation View

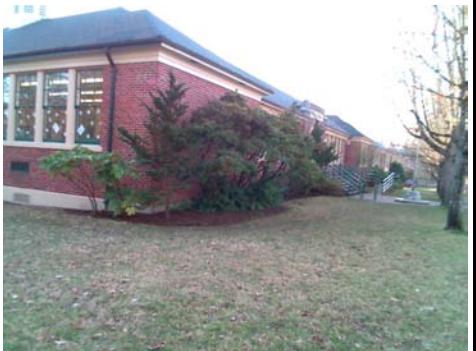
NE Vertical Irregularity Secondary

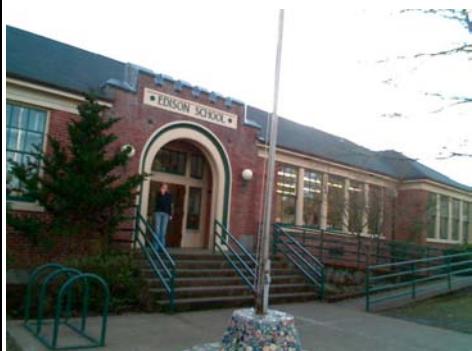
N Falling Hazard

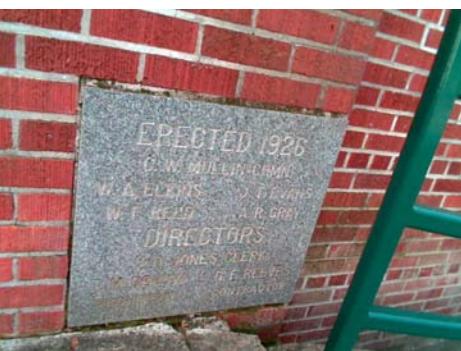
N Field Verified Year Built

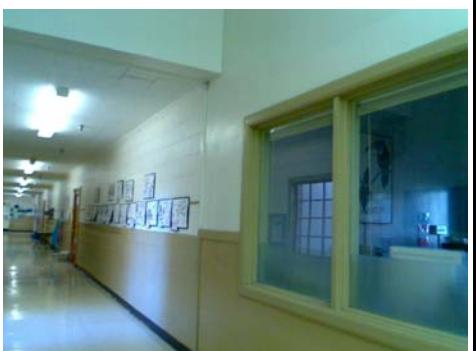
S Primary Structural Type
