Ellis Parker Elementary School

Eugene SD 4J

FEMA 154 Rapid Visual Screening Score Card

Rapid Visual Screening - Senate Bill #2 - Seismic Needs Assessment
Oregon Department of Geology and Mineral Industries

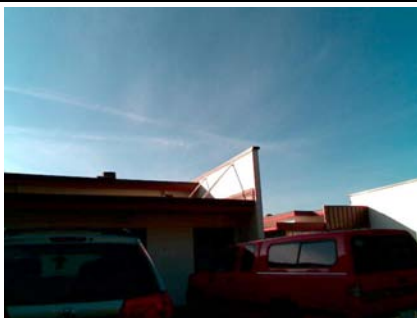
E Seismic Upgrade

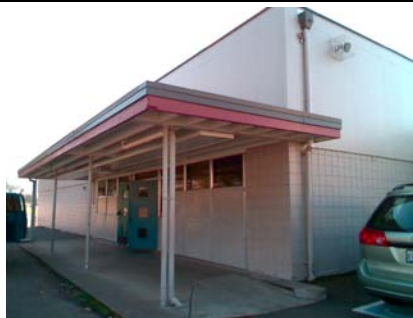
E Primary Structural Type

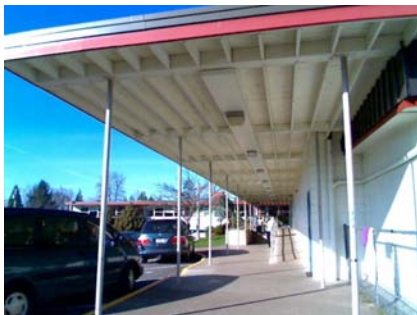
SW Falling Hazard

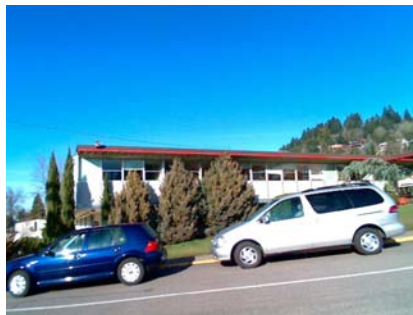
S Vertical Irregularity Tertiary

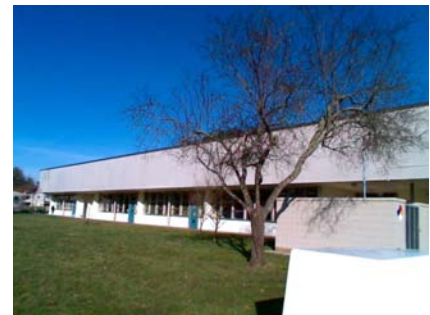
W Vertical Irregularity Secondary

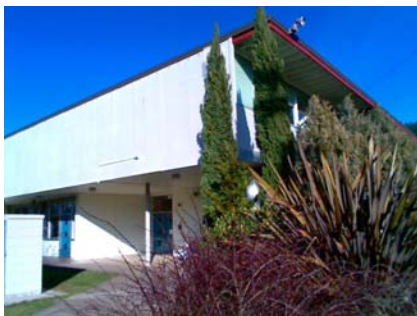
SW Secondary Structural Type

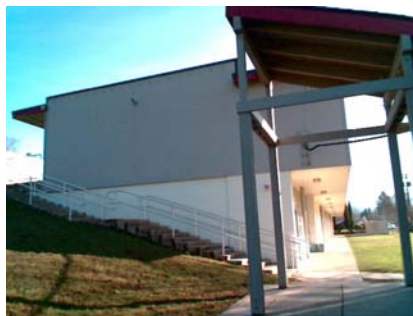
N Vertical Irregularity Tertiary

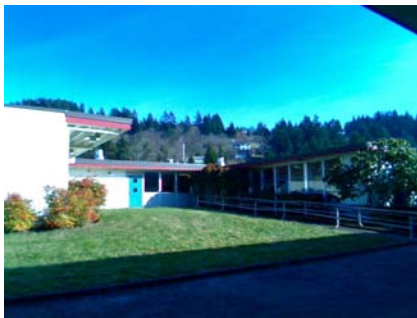
W Plan Irregularity Secondary

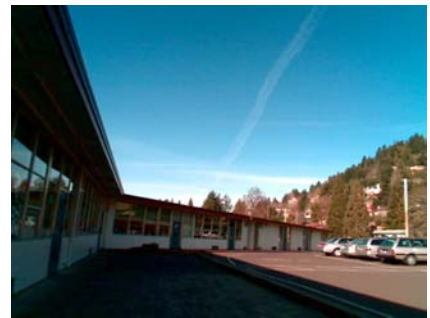
SE Plan Irregularity Primary
