Theodore Roosevelt Middle School

Lane_sch19A

FEMA 154 Rapid Visual Screening Score Card

Rapid Visual Screening - Senate Bill #2 - Seismic Needs Assessment
Oregon Department of Geology and Mineral Industries

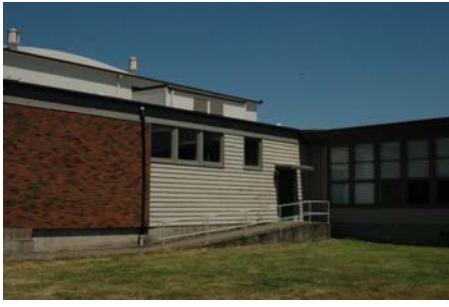
N Vertical Irregularity Secondary		SW Plan Irregularity Primary

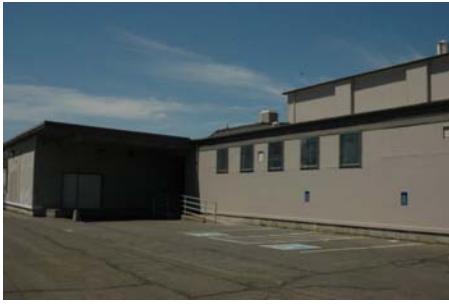
S Plan Irregularity Primary

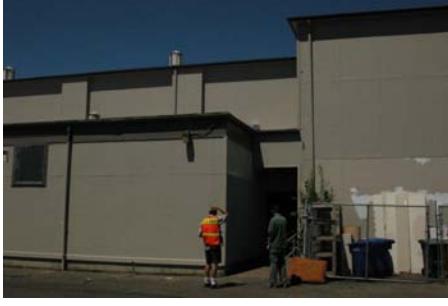
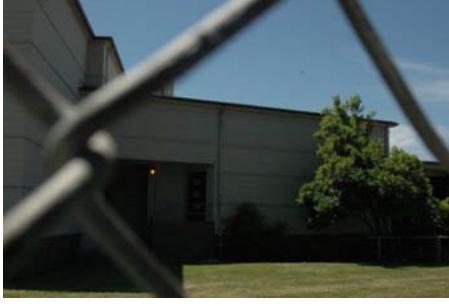
S Vertical Irregularity Primary		E Vertical Irregularity Primary

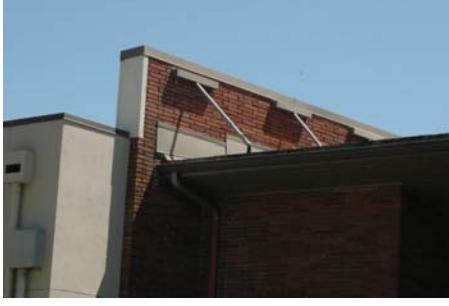
NE Other braced parapets

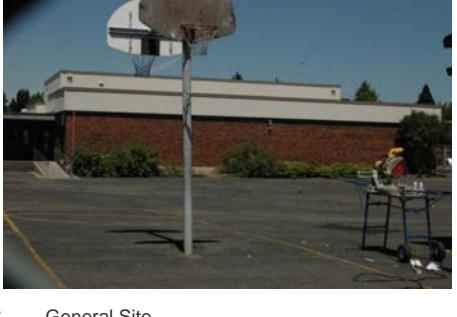
Enrollment 672	Year Built (Field Verified) 1950	Year Built (Alt. Source) 1950	Est. Decade Built 1970
Total Area (square ft) 105770	Number of Stories 1	Basement	Pounding Potential No
Plan Irregularities		Vertical Irregularities	
Reentrant Corners: Other		Steps in Elevation View: Very Irregular Changes	
Reentrant Corners: Other (Adjacent Build/Entity)		Steps in Elevation View: 2 to 3 Changes (Adjacent Building/Entity)	
None		None	
Falling Hazards		Poor Conditions	
None		Open cracks in structural members	
None		None	
None		None

S	Poor Condition	S	Poor Condition
