South Eugene High School

Eugene SD 4J

Lane_sch26A

Rapid Visual Screening - Senate Bill #2 - Seismic Needs Assessment
Oregon Department of Geology and Mineral Industries

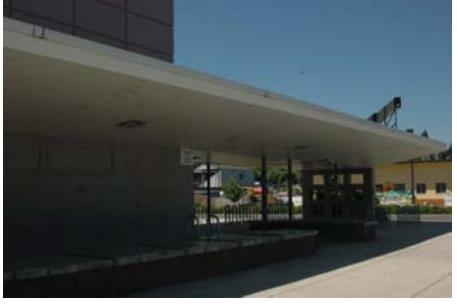
Enrollment 1698	Year Built (Field Verified) 1951	Year Built (Alt. Source) 1951	Est. Decade Built 1950
Total Area (square ft) 309614	Number of Stories 1	Basement	Pounding Potential No
Plan Irregularities		Vertical Irregularities	
Reentrant Corners: Other		Steps in Elevation View: Very Irregular Changes	
Out of Plane Lateral-Force-Resistance Elements		None	
Reentrant Corners: Other (Adjacent Build/Entity)		None	
Falling Hazards		Poor Conditions	
Other: General		Poor Concrete	
None		None	
None		None

N Falling Hazard	S Poor Condition	SW Vertical Irregularity Primary also shows reentrant corner

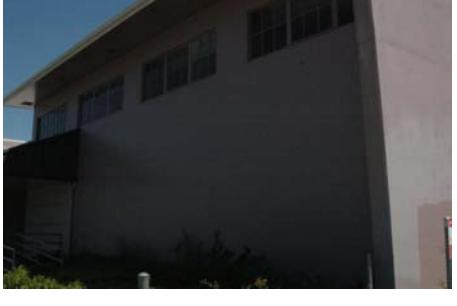
W Primary Structural Type	E Secondary Structural Type	E General Site

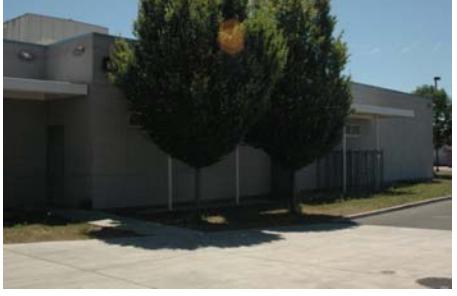
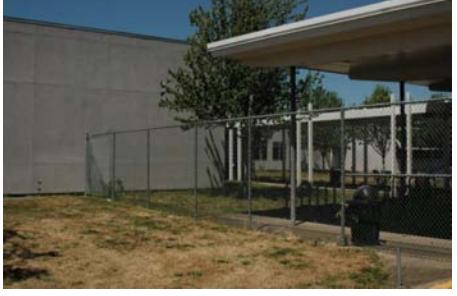
Enrollment 1698	Year Built (Field Verified) 1951	Year Built (Alt. Source) 1951	Est. Decade Built 1990
Total Area (square ft) 309614	Number of Stories 1	Basement	Pounding Potential No
Plan Irregularities Reentrant Corners: Other None None		Vertical Irregularities None None None	
Falling Hazards None None None		Poor Conditions None None None

N Plan Irregularity Primary		E Plan Irregularity Primary

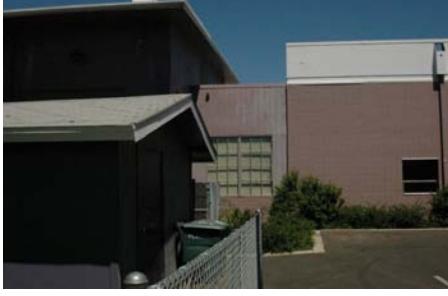
Enrollment 1698	Year Built (Field Verified) 1951	Year Built (Alt. Source) 1951	Est. Decade Built 1990
Total Area (square ft) 309614	Number of Stories 1	Basement	Pounding Potential No
Plan Irregularities None None None		Vertical Irregularities Steps in Elevation View: Single Change (Adjacent Building/Entity) None None	
Falling Hazards None None None		Poor Conditions None None None

S Vertical Irregularity Primary
