# Elmira Elementary School

Fern Ridge SD 28J

## FEMA 154 Rapid Visual Screening Score Card

Rapid Visual Screening - Senate Bill #2 - Seismic Needs Assessment  
Oregon Department of Geology and Mineral Industries

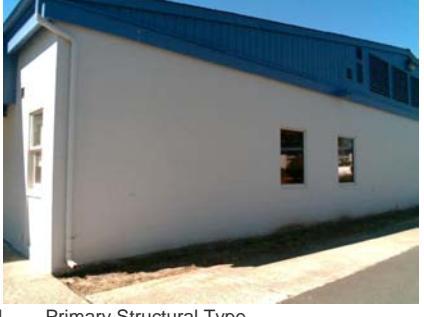
N Primary Structural Type

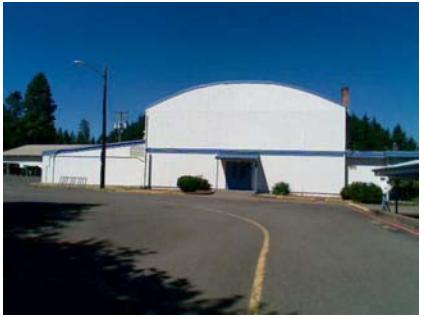
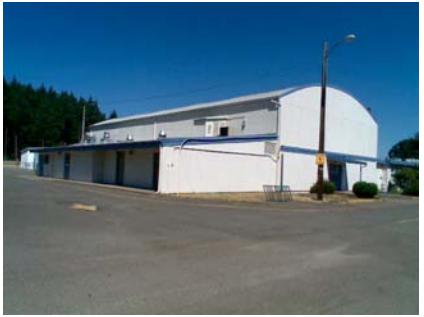
Enrollment 287	Year Built (Field Verified) 1945	Year Built (Alt. Source) 1940	Est. Decade Built 1940
Total Area (square ft) 36486	Number of Stories 1	Basement	Pounding Potential No
Plan Irregularities Reentrant Corners: Other None None		Vertical Irregularities Steps in Elevation View: 2 to 3 Changes None None	
Falling Hazards None None None		Poor Conditions None None None

E Vertical Irregularity Primary		SE Vertical Irregularity Primary

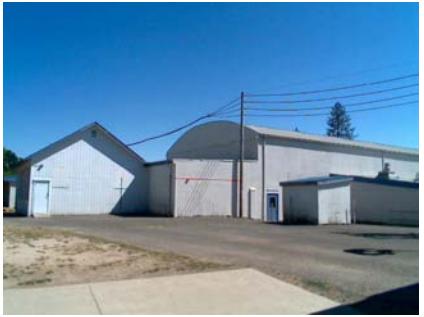
SW Plan Irregularity Primary

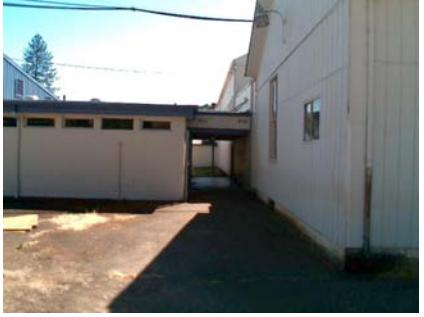
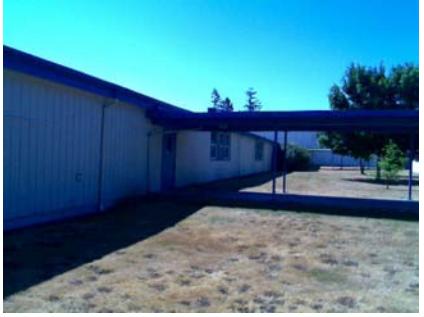
W Other shows the connection between B and C.		NW General Site

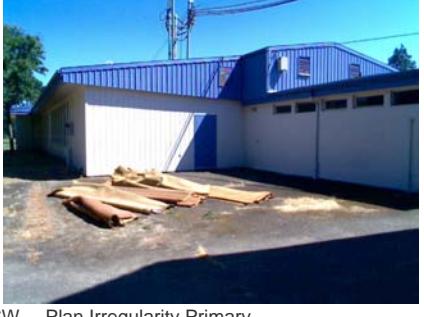
SW Plan Irregularity Primary
