# Elmira High School

Fern Ridge SD 28J

## FEMA 154 Rapid Visual Screening Score Card

Rapid Visual Screening - Senate Bill #2 - Seismic Needs Assessment  
Oregon Department of Geology and Mineral Industries

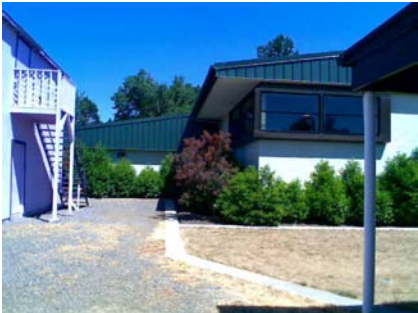
| Reentrant Corners: Other | None |

S Plan Irregularity Primary

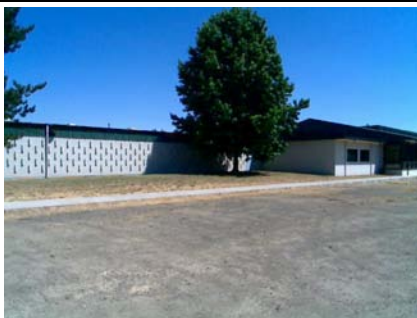
| Reentrant Corners: Other | Steps in Elevation View: Single Change |

S Plan Irregularity Primary

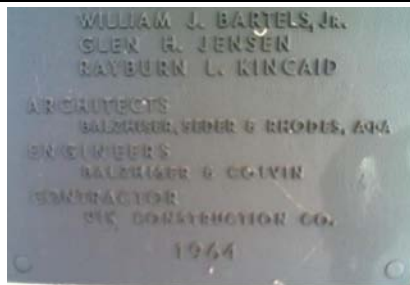
E Field Verified Year Built  
construction date 1964

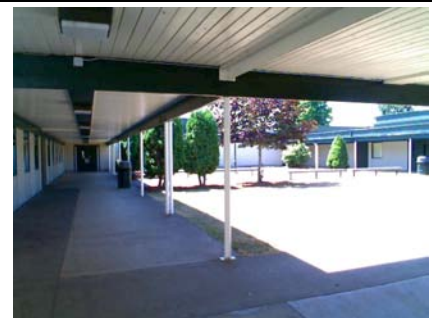
N Plan Irregularity Primary

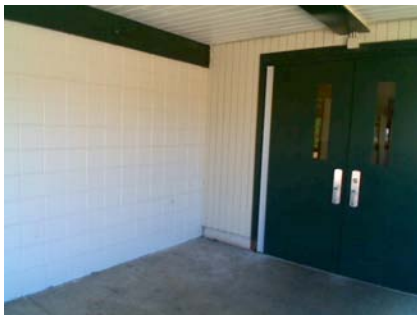
NW Primary Structural Type  
also shows secondary structural type

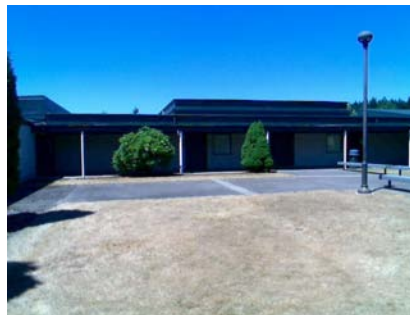
E Vertical Irregularity Primary

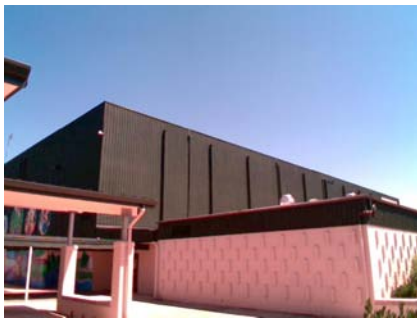
| Reentrant Corners: Other | Steps in Elevation View: Single Change |

SW Vertical Irregularity Primary

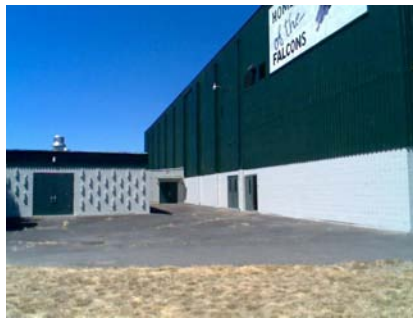
SE Plan Irregularity Primary  
also shows vertical irreg.
