Malabon Elementary School

Bethel SD 52

Lane_sch59A

Rapid Visual Screening - Senate Bill #2 - Seismic Needs Assessment
Oregon Department of Geology and Mineral Industries

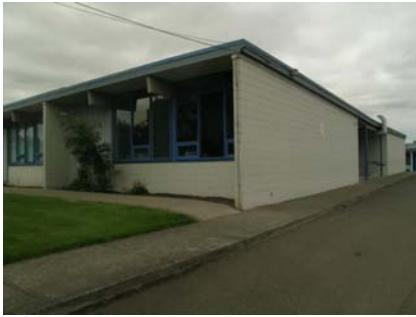
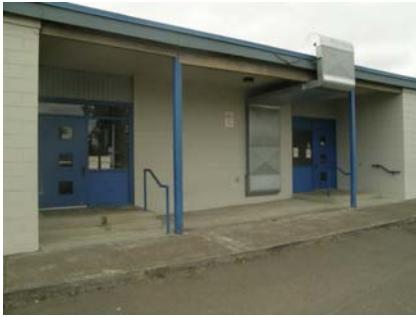
N Elevation View		N Plan Irregularity Primary	
		W Vertical Irregularity Primary

S Vertical Irregularity Primary

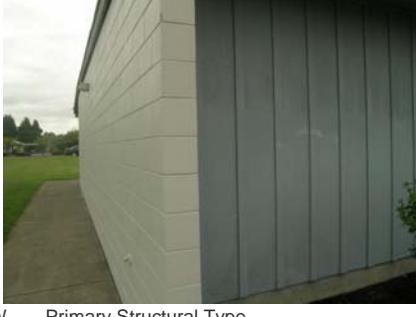
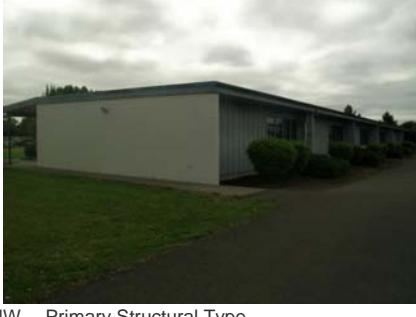
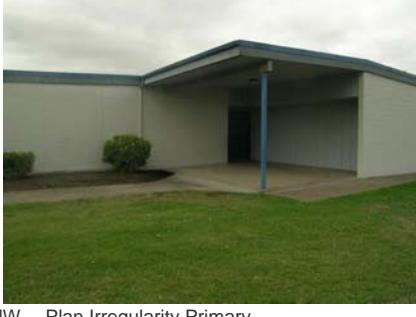
W Primary Structural Type and secondary structural type	NW Primary Structural Type	NW Plan Irregularity Primary

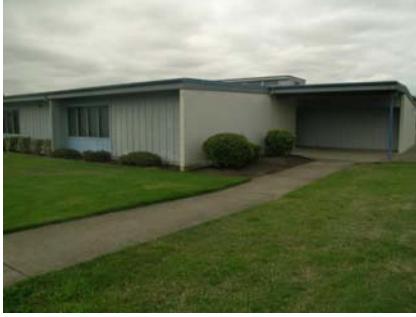
N Plan Irregularity Primary

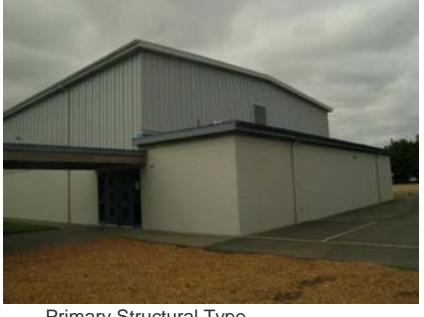
E Primary Structural Type and secondary structural type. W2 on the upper level and RM1 on the lower level		SE Primary Structural Type and secondary structural type.	
		W Elevation View

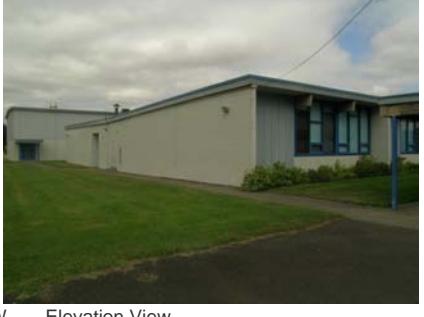
W Elevation View
