Shasta Middle School

Bethel SD 52

FEMA 154 Rapid Visual Screening Score Card

Rapid Visual Screening - Senate Bill #2 - Seismic Needs Assessment
Oregon Department of Geology and Mineral Industries

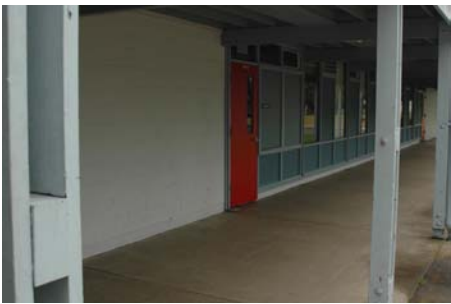
E Primary Structural Type

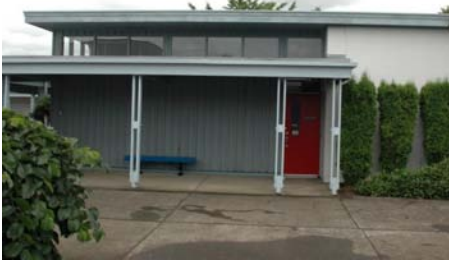
W Primary Structural Type
and secondary structural type.

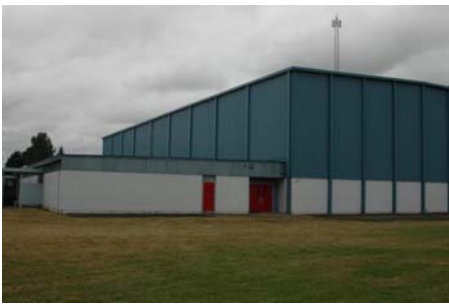
Plan Irregularities	Vertical Irregularities
None	Steps in Elevation View: Single Change (Adjacent Building/Entity)
None	None
None	None

SW Vertical Irregularity Primary
