Junction City SD 69

Lane_sch64A

Rapid Visual Screening - Senate Bill #2 - Seismic Needs Assessment
Oregon Department of Geology and Mineral Industries

Junction City High School

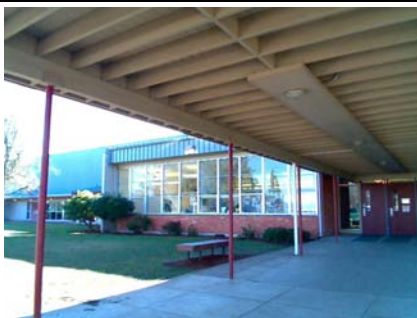
N Falling Hazard

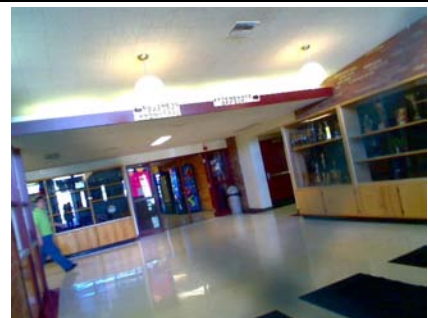
N Secondary Structural Type
brick hall walls

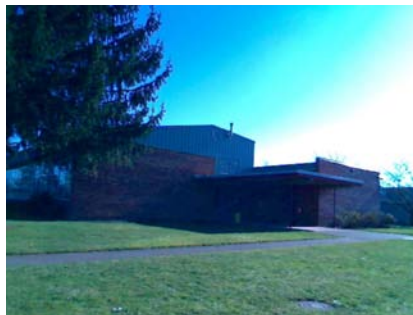
NW Vertical Irregularity Primary

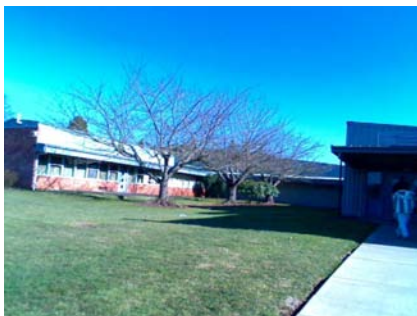
W Plan Irregularity Primary

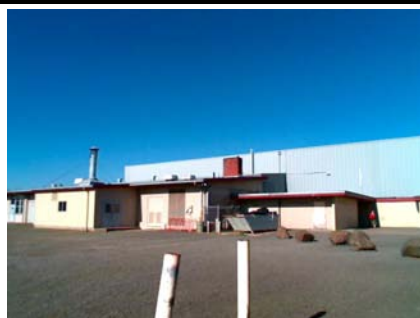
SE Plan Irregularity Primary

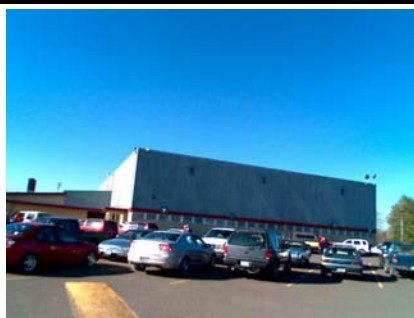
E Elevation View
windows blocked in upgrade

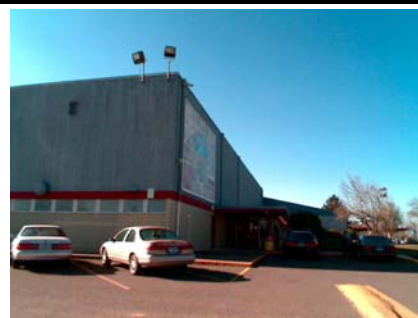
E Plan Irregularity Secondary

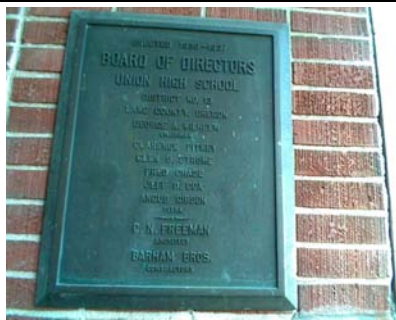
E Field Verified Year Built
1937

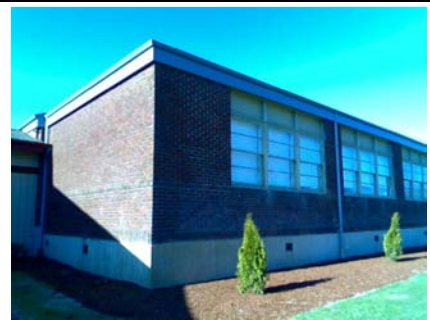
SE Plan Irregularity Secondary
crack in veneer

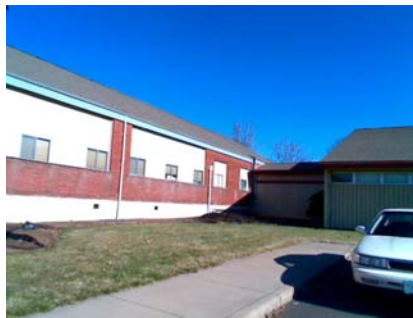
SW Vertical Irregularity Secondary
