# Oakridge High School

Lane\_sch67A

## FEMA 154 Rapid Visual Screening Score Card

Rapid Visual Screening - Senate Bill #2 - Seismic Needs Assessment  
Oregon Department of Geology and Mineral Industries

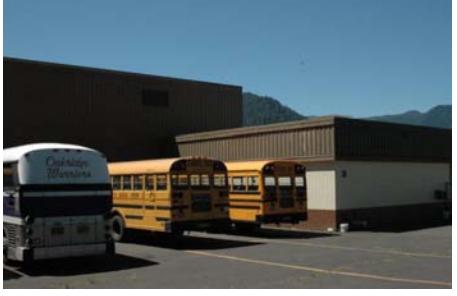
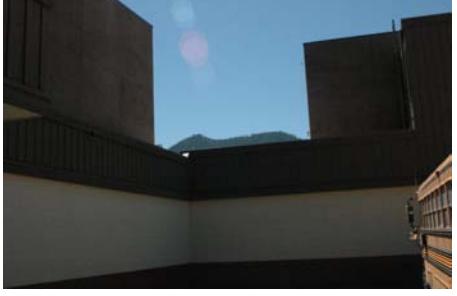
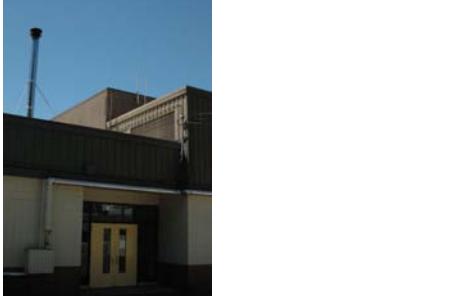
NE Vertical Irregularity Primary and reentrant corner	NE Vertical Irregularity Primary and reentrant corner	NE Vertical Irregularity Primary

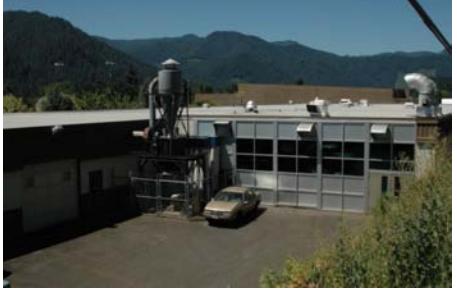
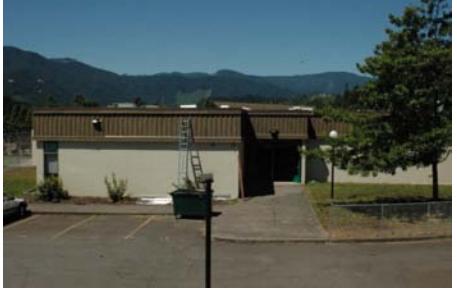
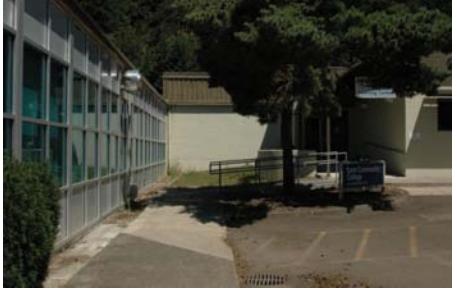
NE Plan Irregularity Primary	E General Site	SE Plan Irregularity Primary

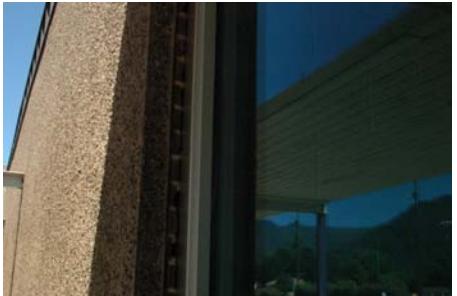
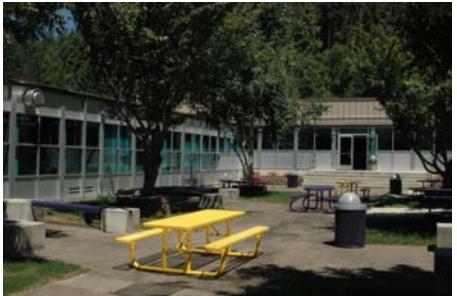
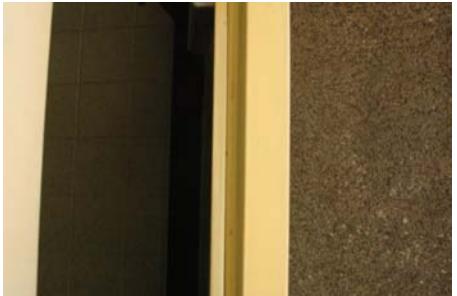
S Primary Structural Type brickwork behind façade	S General Site	SE Primary Structural Type left is inside gym entrance, center is the door I am holding open, right is the façade outside that is covering the rm1.
