Siuslaw High School

Lane_sch70A

FEMA 154 Rapid Visual Screening Score Card

Rapid Visual Screening - Senate Bill #2 - Seismic Needs Assessment
Oregon Department of Geology and Mineral Industries

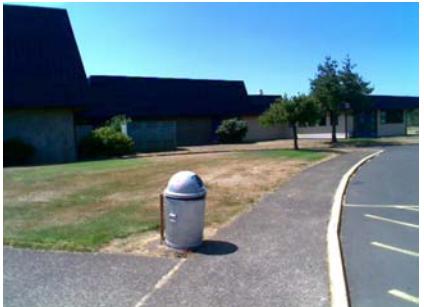
| E Plan Irregularity Primary | | NE Vertical Irregularity Primary | |

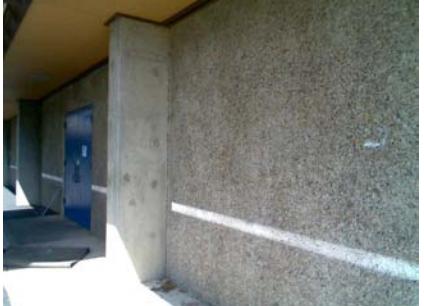
| N General Site | | W Tertiary Structural Type | |

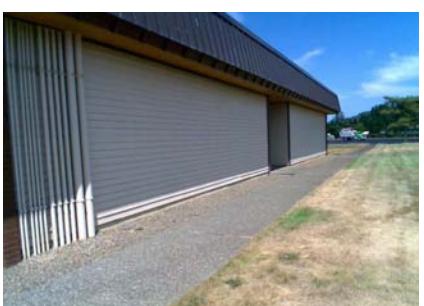
| S Secondary Structural Type | | SE Plan Irregularity Primary | |

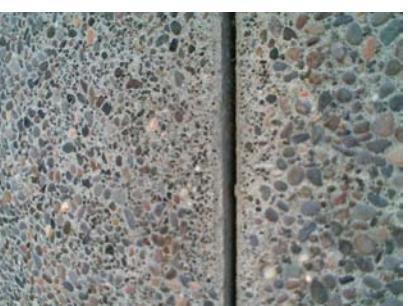
| E Primary Structural Type | | | |

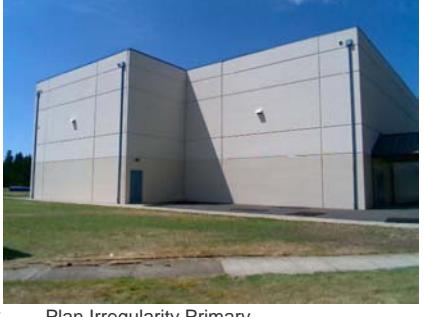
| S Plan Irregularity Primary | | | |

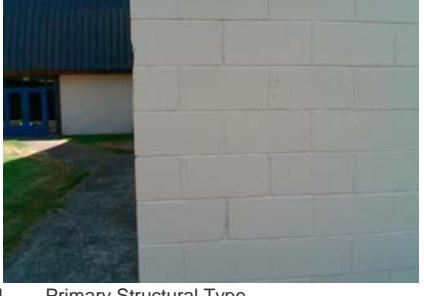
| NE General Site | N Primary Structural Type | NW General Site | |
