Yujin Gakuen (Japanese) School

Eugene SD 4J

FEMA 154 Rapid Visual Screening Score Card

Rapid Visual Screening - Senate Bill #2 - Seismic Needs Assessment
Oregon Department of Geology and Mineral Industries

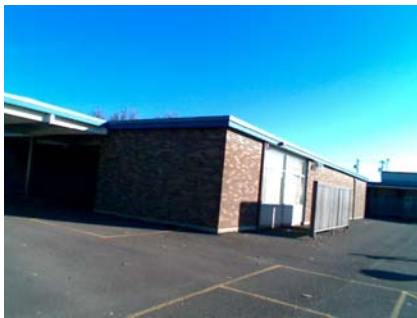
SW Elevation View

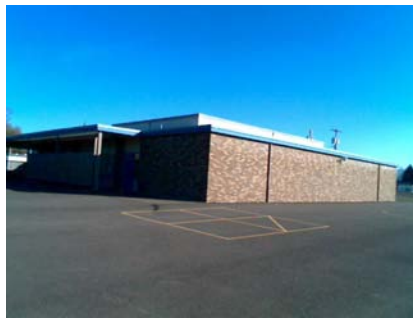
SW Elevation View
mech screen on roof

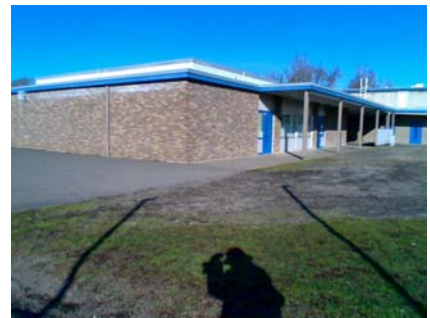
Falling Hazards	Poor Conditions
Other: Ornamental Hazard Over Exit	None
Other: Brick Veneer	None
None	None

SE Falling Hazard

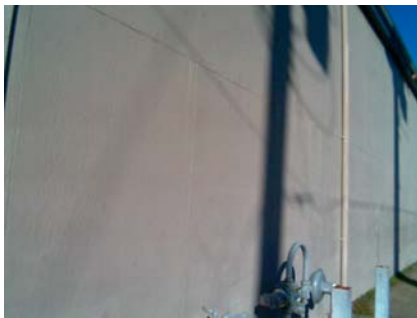
E Primary Structural Type
plywood

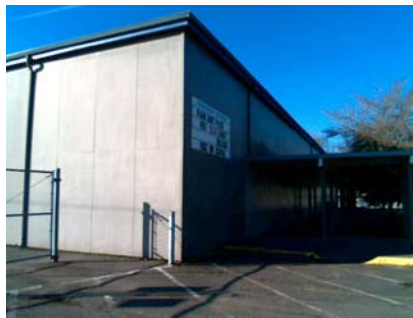
Enrollment	Year Built (Field Verified)	Year Built (Alt. Source)	Est. Decade Built
309		1961	1960
Total Area (square ft)	Number of Stories	Basement	Pounding Potential
22220	1	No	Yes

NE Pounding Potential

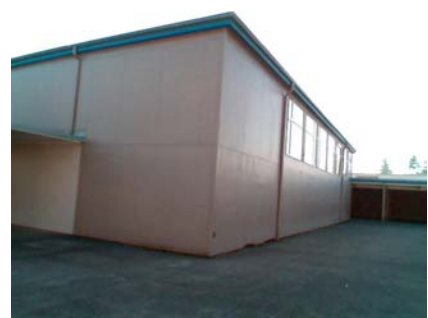
NW Elevation View
