Village School

Eugene SD 4J

FEMA 154 Rapid Visual Screening Score Card

Rapid Visual Screening - Senate Bill #2 - Seismic Needs Assessment
Oregon Department of Geology and Mineral Industries

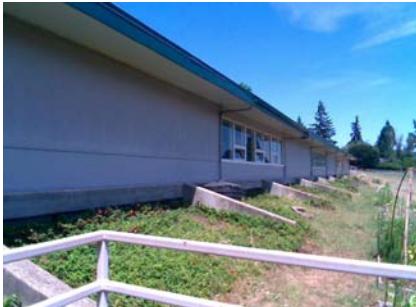
| W General Site | | | |

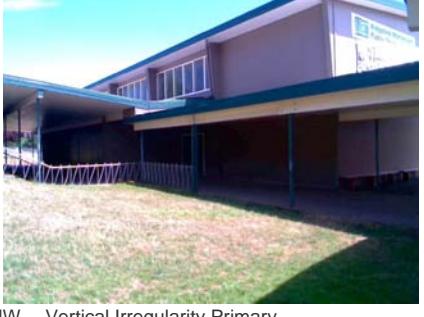
| Plan Irregularities Reentrant Corners: Other None None | | Vertical Irregularities Steps in Elevation View: Single Change None None | |
| NW Vertical Irregularity Primary | | | |

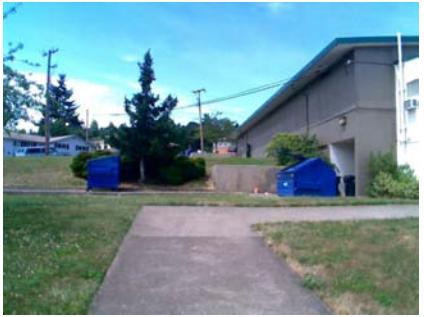
| Plan Irregularities Reentrant Corners:Other (Adjacent Build/Entity) None | | Vertical Irregularities Building On Hill or Sloped Site Steps in Elevation View: Single Change (Adjacent Building/Entity) None | |
| W Vertical Irregularity Primary reentrant corner | | W General Site | |
