Ridgeline Montessori

Eugene SD 4J

Lane_sch91A

FEMA 154 Rapid Visual Screening Score Card

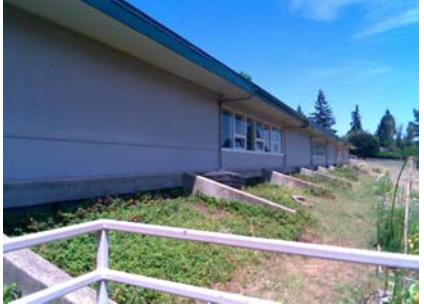
<p>W General Site also shows small retaining walls.</p>

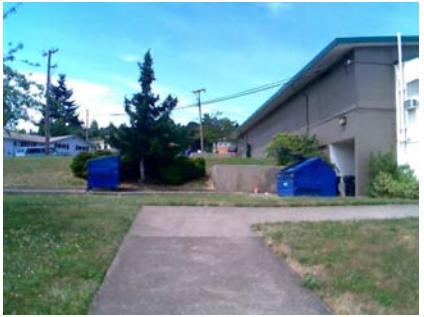
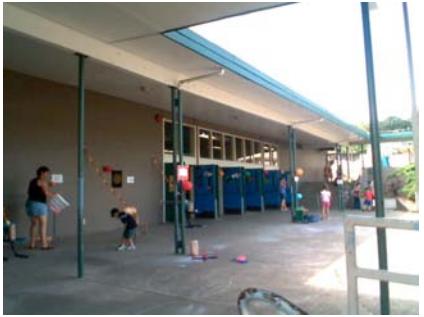
W Vertical Irregularity Primary Sloped site.		W General Site
