Lundy Elementary School

Lane_sch95A

FEMA 154 Rapid Visual Screening Score Card

Rapid Visual Screening - Senate Bill #2 - Seismic Needs Assessment
Oregon Department of Geology and Mineral Industries

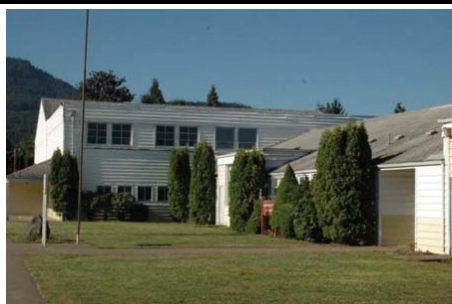
NE Plan Irregularity Primary
Also shows a step in elevation.

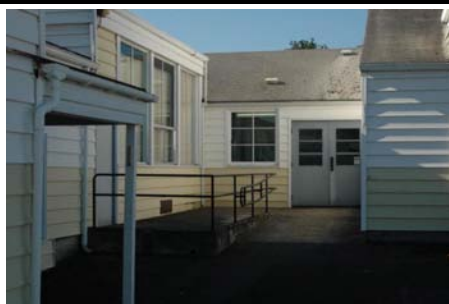
NE Plan Irregularity Primary

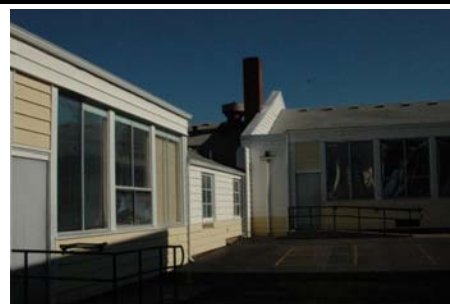
SE Falling Hazard
Also shows a reentrant corner.

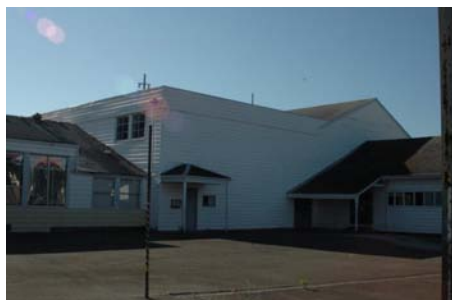
N Vertical Irregularity Secondary

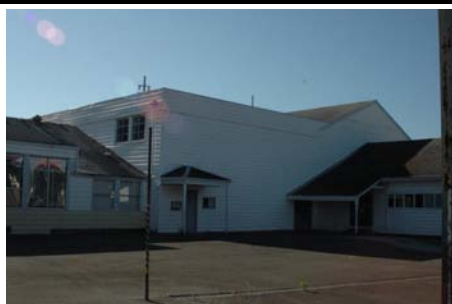
SE Vertical Irregularity Primary

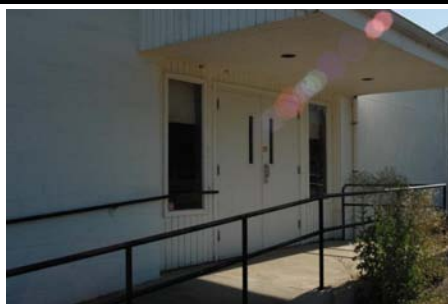
S Primary Structural Type
and secondary structural type
