Coburg Elementary School

Eugene SD 4J

FEMA 154 Rapid Visual Screening Score Card

Rapid Visual Screening - Senate Bill #2 - Seismic Needs Assessment
Oregon Department of Geology and Mineral Industries

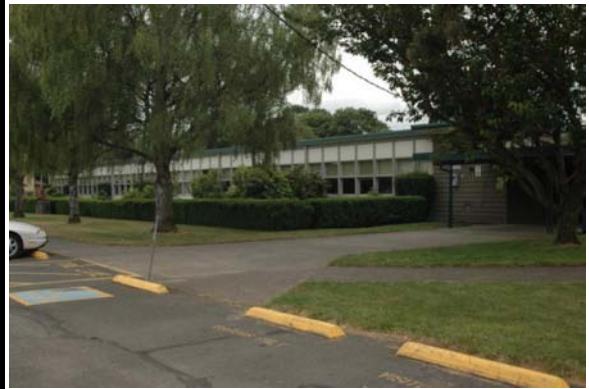
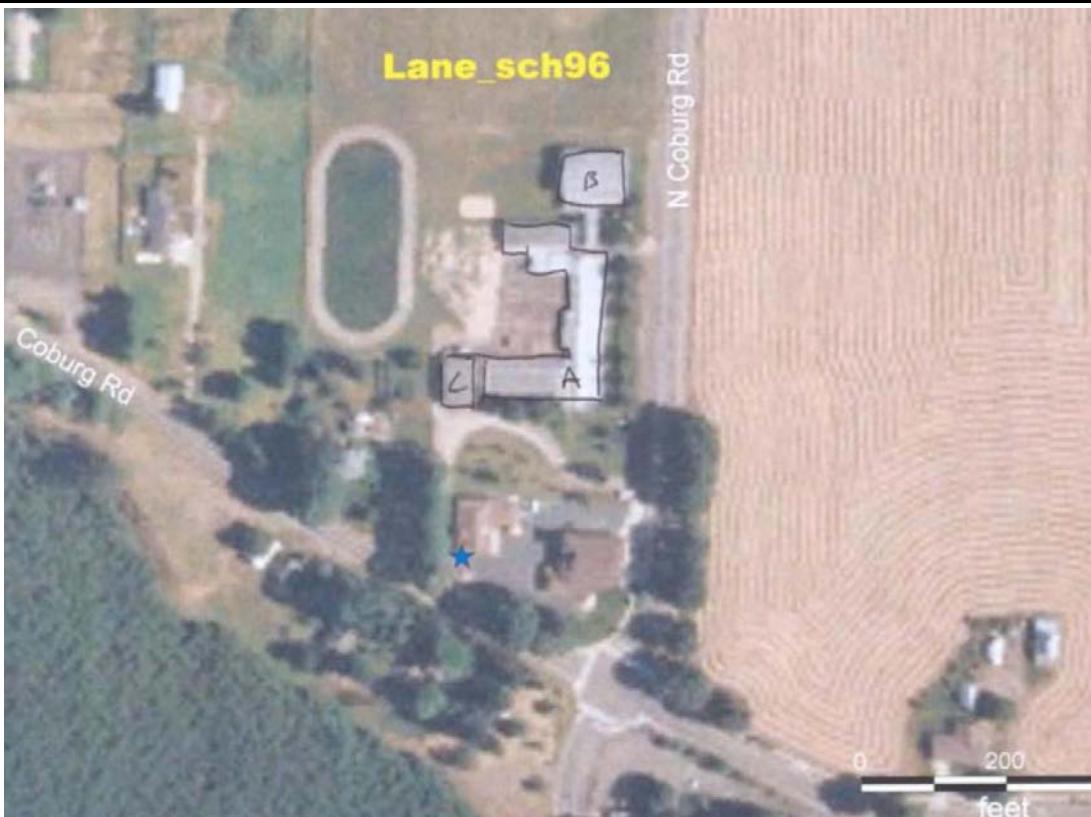
Lane_sch96A

High (>10%)

Enrollment 150	Year Built (Field Verified) 1950	Year Built (Alt. Source) 1950	Est. Decade Built 1950
Total Area (square ft) 27537	Number of Stories 1	Basement	Pounding Potential No
Plan Irregularities Reentrant Corners: U shaped None None		Vertical Irregularities Steps in Elevation View: 2 to 3 Changes None None	
Falling Hazards None None None		Poor Conditions None None None

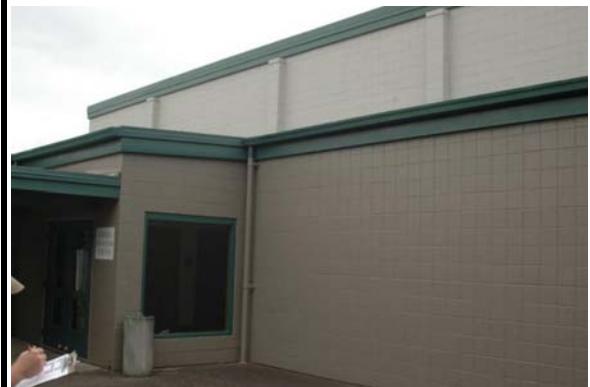
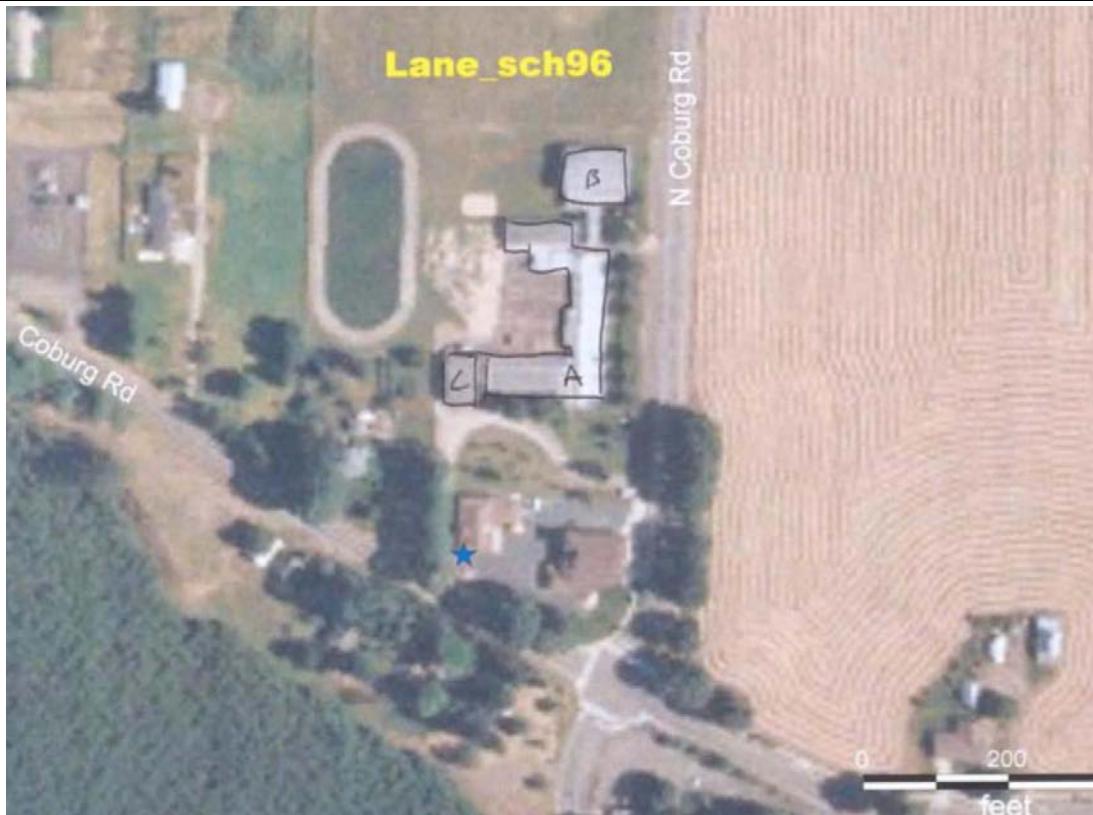
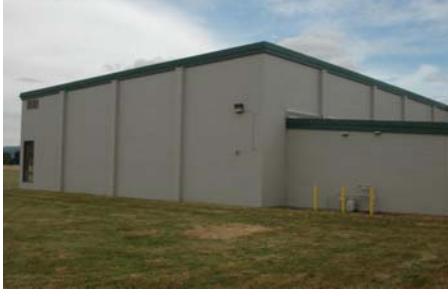
Lane_sch96B

High (>10%)

Enrollment 150	Year Built (Field Verified) 1950	Year Built (Alt. Source) 1950	Est. Decade Built 1970
Total Area (square ft) 27537	Number of Stories 1	Basement	Pounding Potential No
Plan Irregularities Out of Plane Lateral-Force-Resistance Elements None None		Vertical Irregularities Steps in Elevation View: Single Change None None	
Falling Hazards None None None		Poor Conditions None None None

W Vertical Irregularity Primary out of plane lateral system also

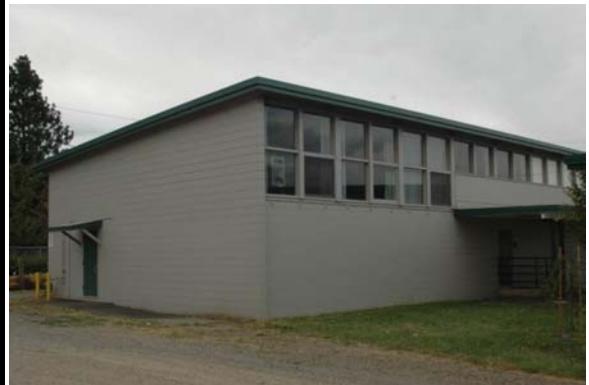
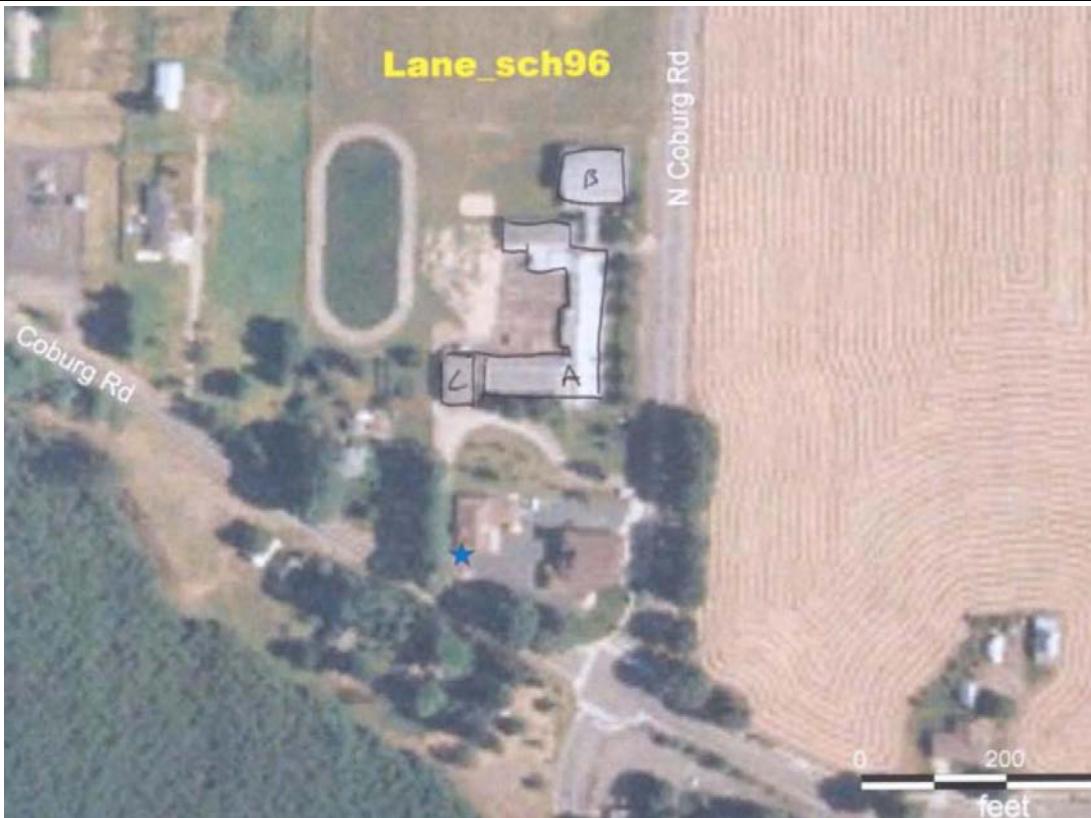
Lane_sch96C

Moderate (>1%)

Enrollment 150	Year Built (Field Verified) 1950	Year Built (Alt. Source) 1950	Est. Decade Built 1960
Total Area (square ft) 27537	Number of Stories 1	Basement	Pounding Potential No
Plan Irregularities Torsion: Eccentric Stiffness None None		Vertical Irregularities None None None	
Falling Hazards None None None		Poor Conditions None None None
