# North Lincoln Fire & Rescue

Linc\_fir01A

Building Type Fire - RFPD	County Lincoln	
Street 2525 NW Hwy 101		
City Lincoln City	State OR	Zip 97367
Latitude 44.98366	Longitude 124.00765	
Tracking Code RVS in 2006	Inspection Date 8/8/2006

## FEMA 154 Rapid Visual Screening Score Card

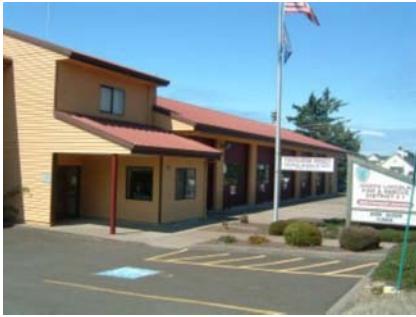
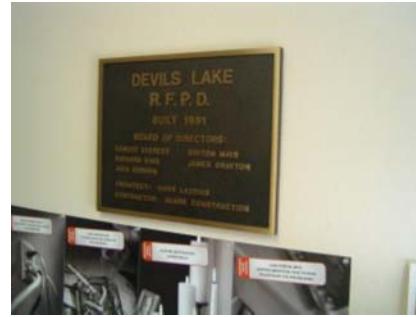
SE Vertical Irregularity Primary reentrant corner also		S Field Verified Year Built

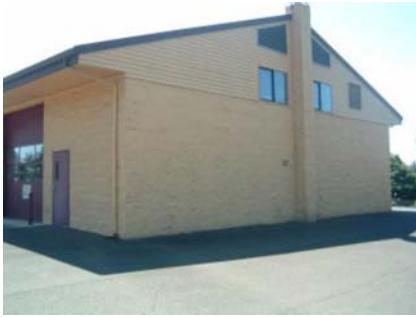
NW Secondary Structural Type

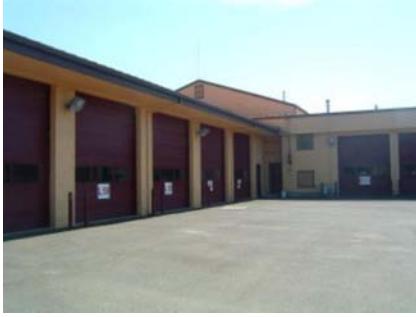
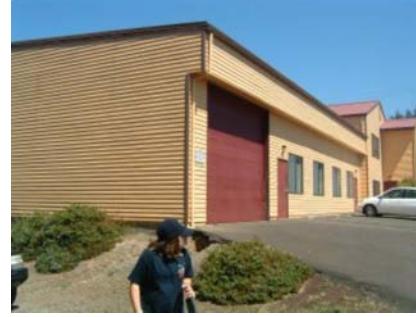
NW Plan Irregularity Primary		SW Primary Structural Type
