North Lincoln Fire & Rescue

Linc_fir03A

FEMA 154 Rapid Visual Screening Score Card

Rapid Visual Screening - Senate Bill #2 - Seismic Needs Assessment
Oregon Department of Geology and Mineral Industries

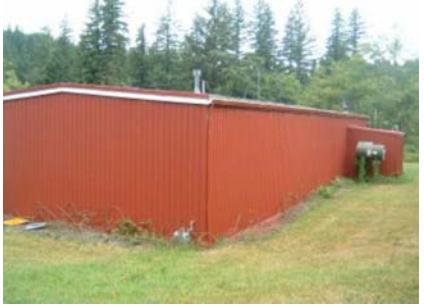
SW General Site ignore small attached power shed in irregularities

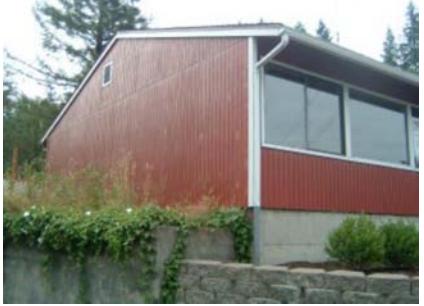
NE Primary Structural Type
