Yachats RFPD & S. Lincoln Ambulance Service

Linc_fir08A

FEMA 154 Rapid Visual Screening Score Card

Rapid Visual Screening - Senate Bill #2 - Seismic Needs Assessment
Oregon Department of Geology and Mineral Industries

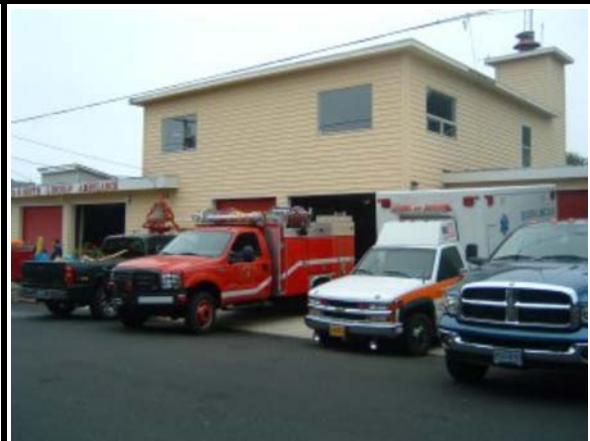
Final Type	Final Score
W2	-0.1

Very High (100%)

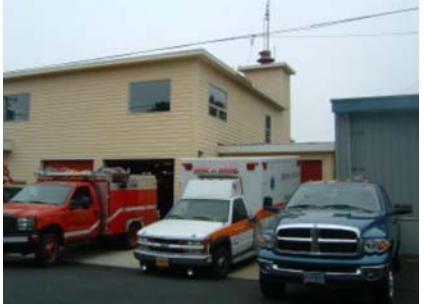
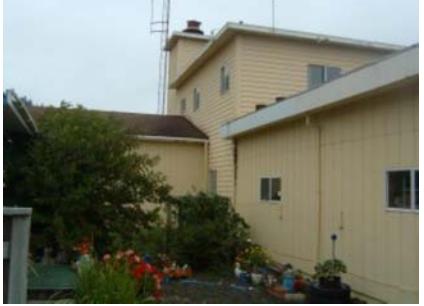
S Vertical Irregularity Secondary out-of-plane offset also		NW Plan Irregularity Tertiary step in elevation also

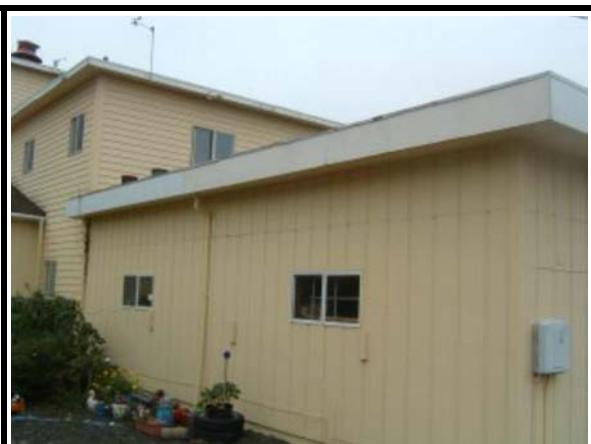
Linc_fir08B

Final Type	Final Score
W1	1.4

Moderate (>1%)

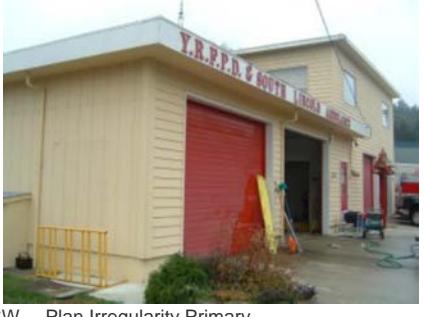
SW Plan Irregularity Primary

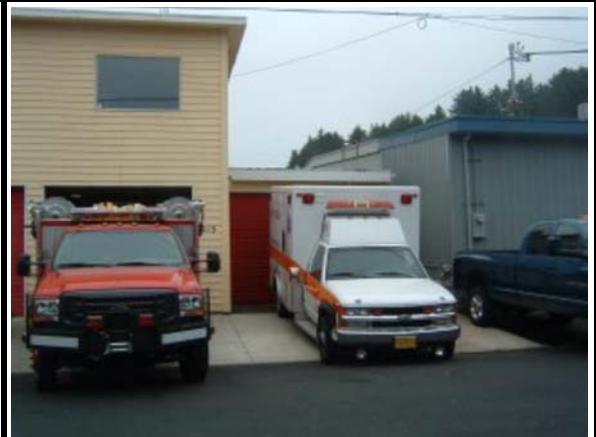
Linc_fir08C

Final Type	Final Score
W1	3.8

Low (<1%)
