# North Lincoln Fire & Rescue

Linc\_fir12A

Rapid Visual Screening - Senate Bill #2 - Seismic Needs Assessment  
Oregon Department of Geology and Mineral Industries

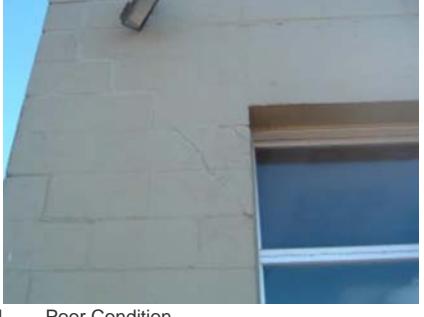
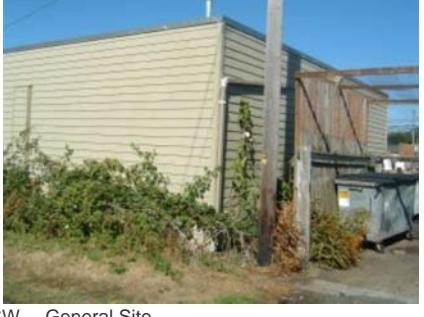
N Poor Condition cracks		SW General Site
