# North Lincoln Fire & Rescue - Kernville Station

Linc\_fir14A

## FEMA 154 Rapid Visual Screening Score Card

Rapid Visual Screening - Senate Bill #2 - Seismic Needs Assessment  
Oregon Department of Geology and Mineral Industries

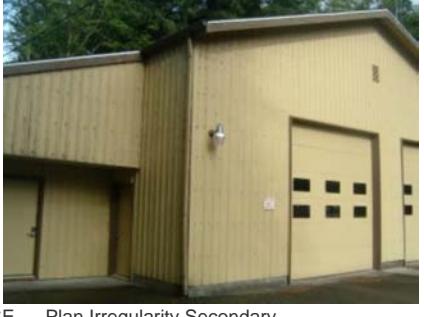
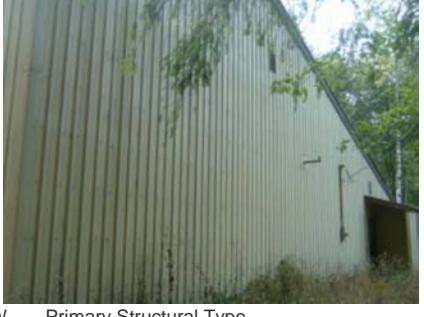
SE	Plan Irregularity Secondary	W	Primary Structural Type
